**THE SEARCH FOR THE CRASH SITE
OF AVRO LANCASTER MK I
R 5694 EM-F
PLANE FIELD SK 793 279**

NEAR EATON, LEICESTERSHIRE

**FIELD SURVEY
REPORT**

SEPTEMBER 2020

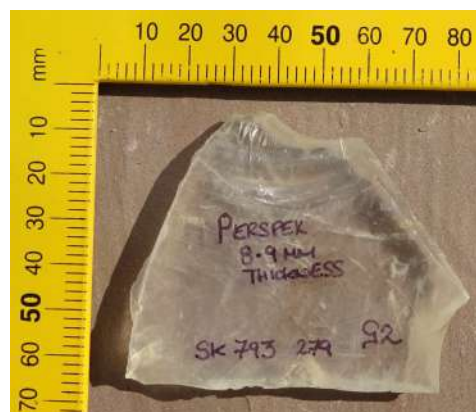
Piece of Perspex windscreen

The initial flight trajectory was a little out, and the concentrations of artefacts suggest that the aircraft came to ground at an angle more adjacent to that of the stream than first thought. This alignment of wreckage could suggest that there was a last minute manoeuvre by the pilot to avert a collision with high ground on plane field. One particular artefact brought those terrifying last moments that the crew must have lived through into view; a piece of Perspex windscreen.

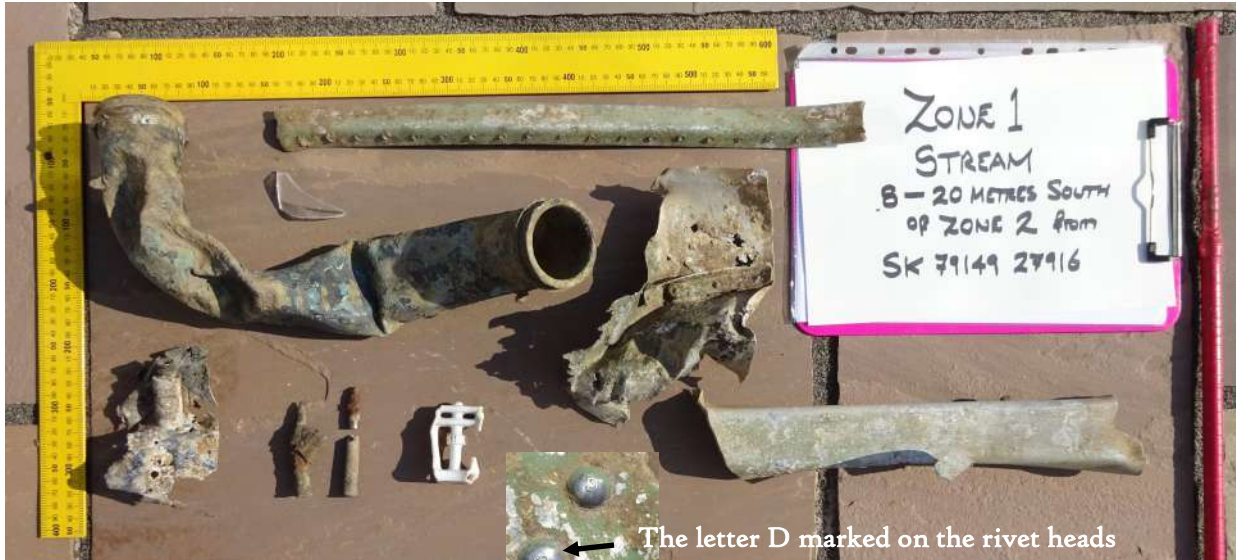
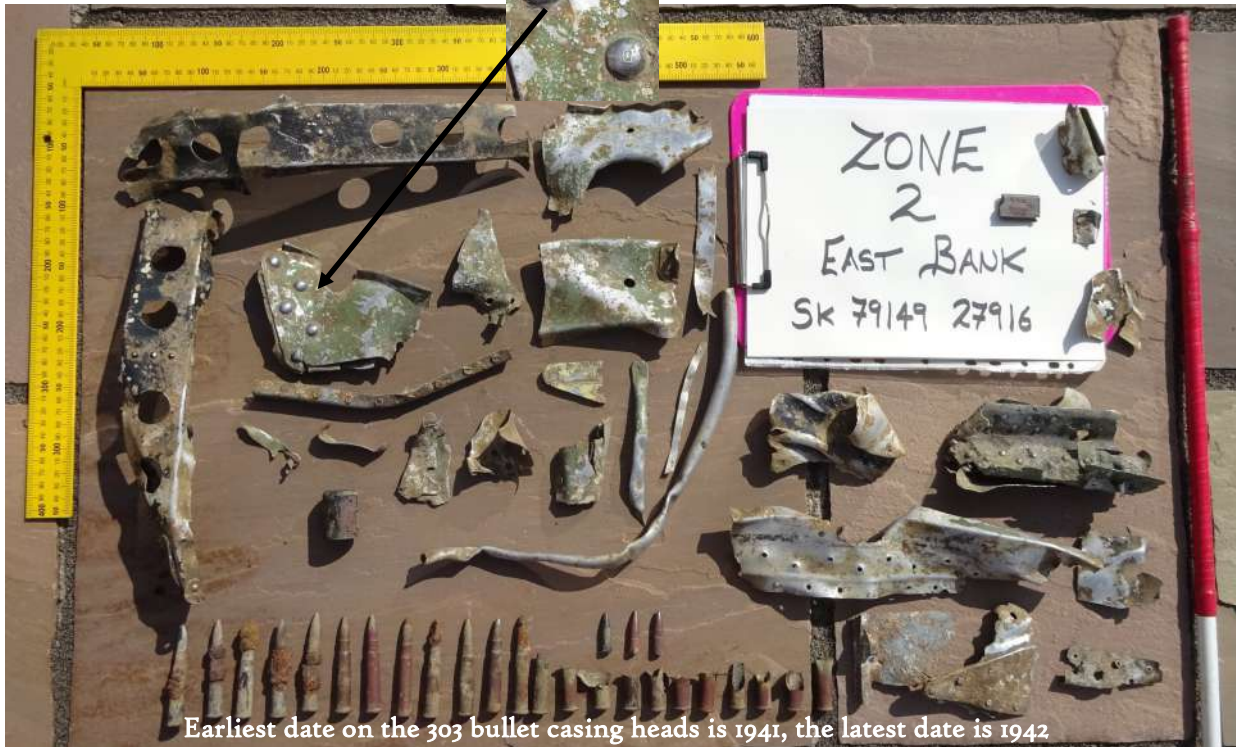
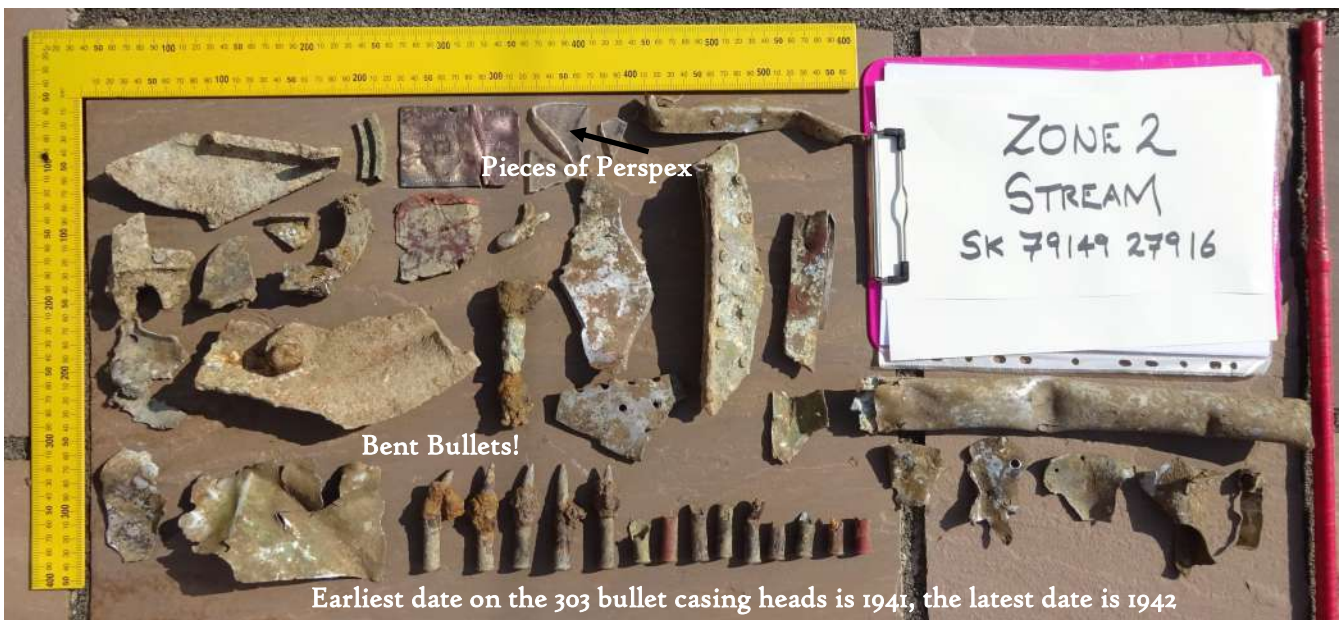
SEARCH GRID ARTEFACTS

The metallic artefacts found during the search grid survey, increased in quantity the nearer we reached the east bank of the stream.

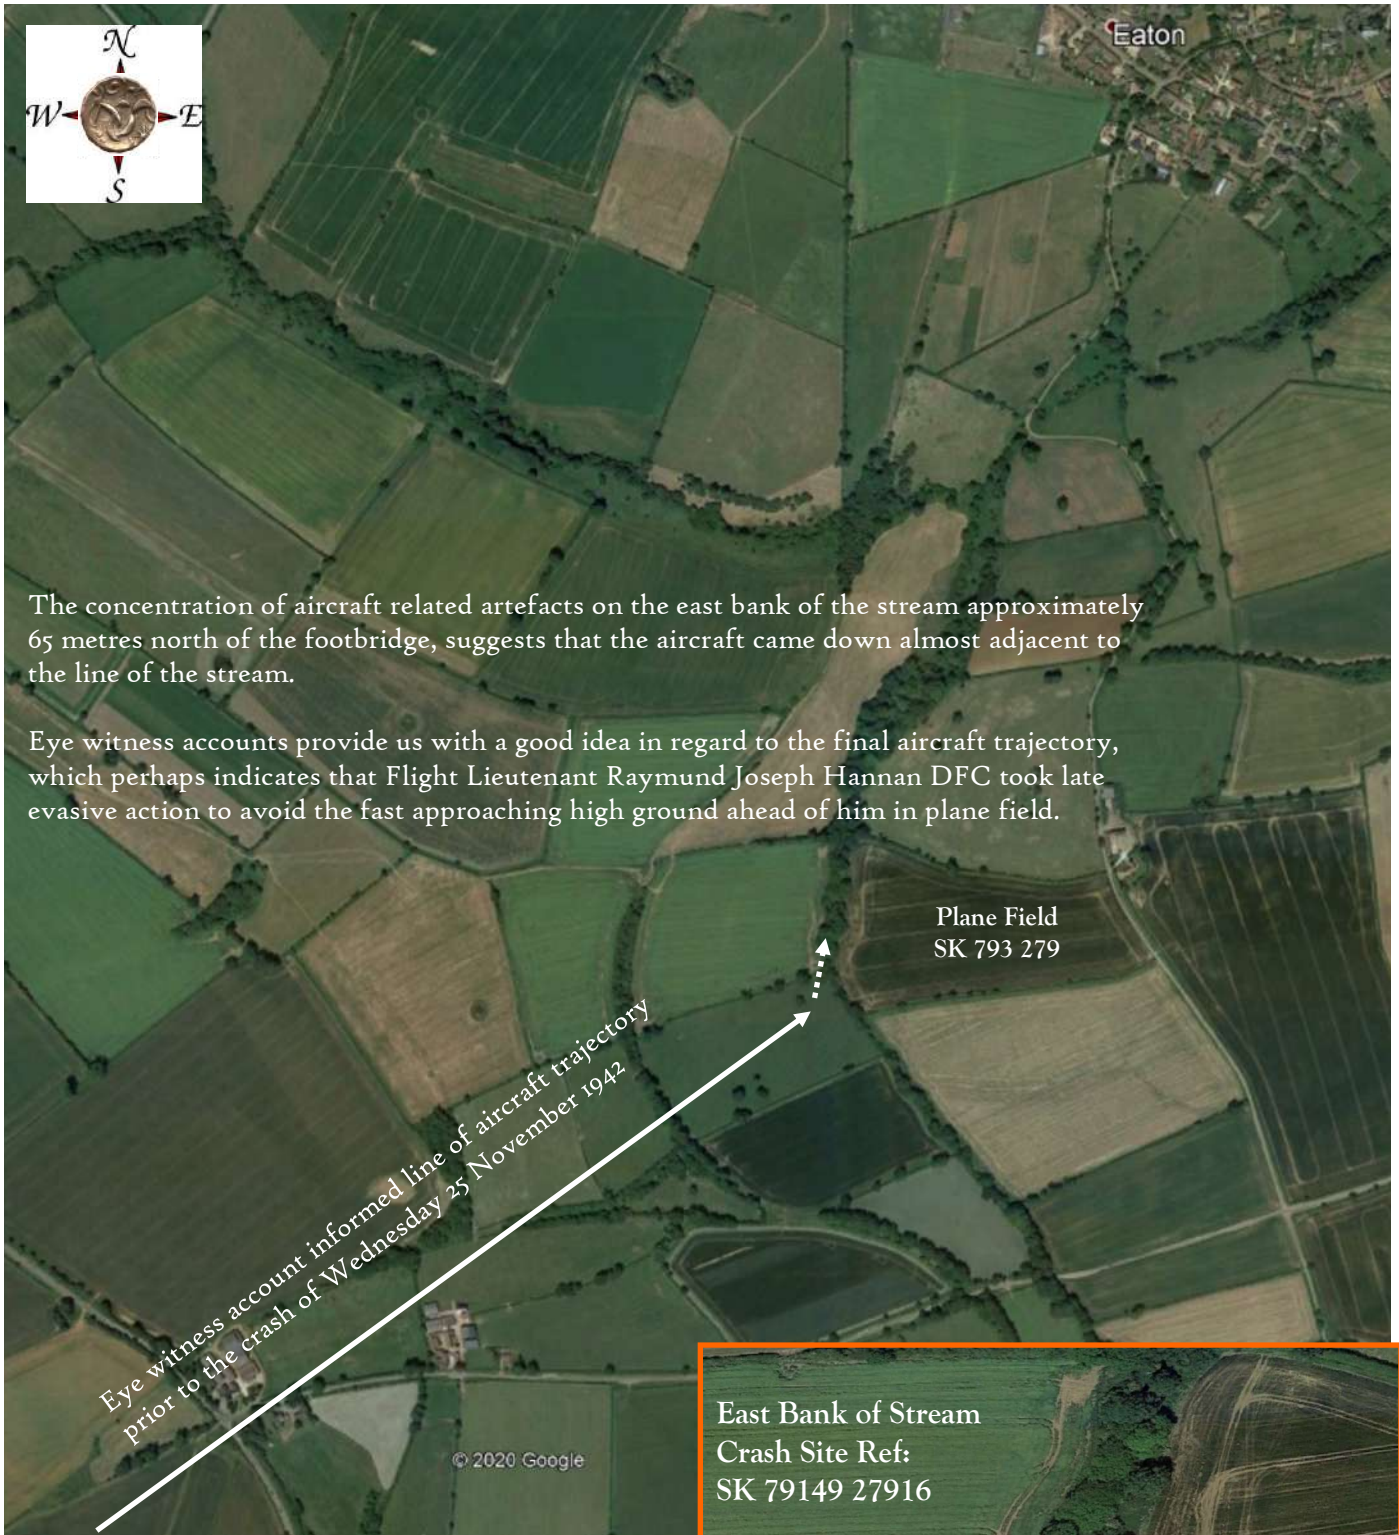
POST FIELD SURVEY REVISED AIRCRAFT TRAJECTORY

The concentration of aircraft related artefacts on the east bank of the stream approximately 65 metres north of the footbridge, suggests that the aircraft came down almost adjacent to the line of the stream.

Eye witness accounts provide us with a good idea in regard to the final aircraft trajectory, which perhaps indicates that Flight Lieutenant Raymund Joseph Hannan DFC took late evasive action to avoid the fast approaching high ground ahead of him in plane field.

Eye witness account informed line of aircraft trajectory
prior to the crash of Wednesday 25 November 1942

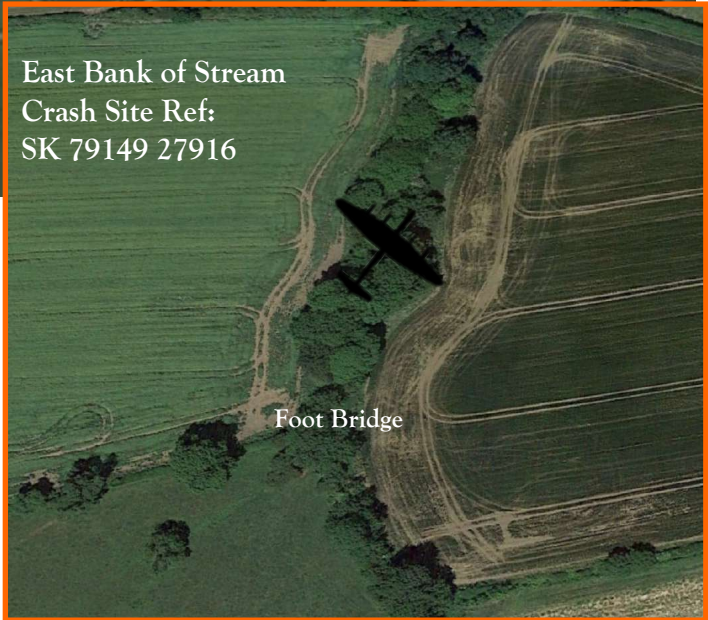
The image featured right shows the position of the Avro Lancaster MK I R5694 EM-F aircraft, as informed by the results of the Field Detectives survey following the fateful crash of Wednesday 25th November 1942 which happened at approximately 16:10 - 16:20 hours.

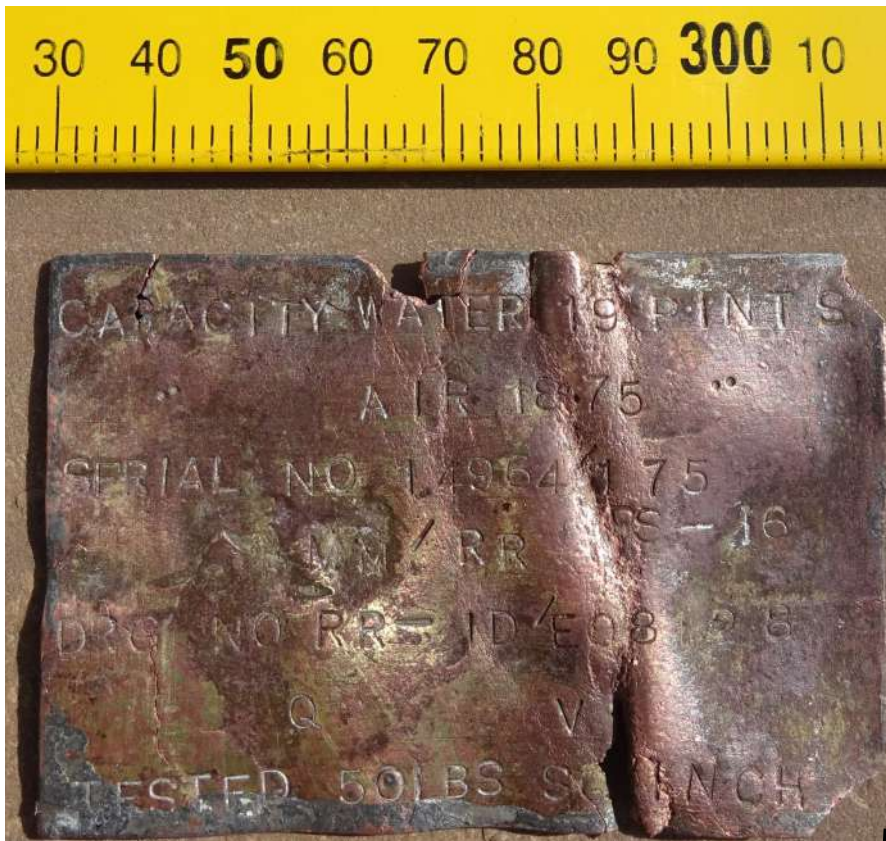
Found in the stream - Zone 2, close to the crash site reference SK 79149 27916

I just wanted to confirm that the plate above is from the coolant header tank on the top of one of the engines - Louise Bush Lincolnshire Aviation Heritage Centre

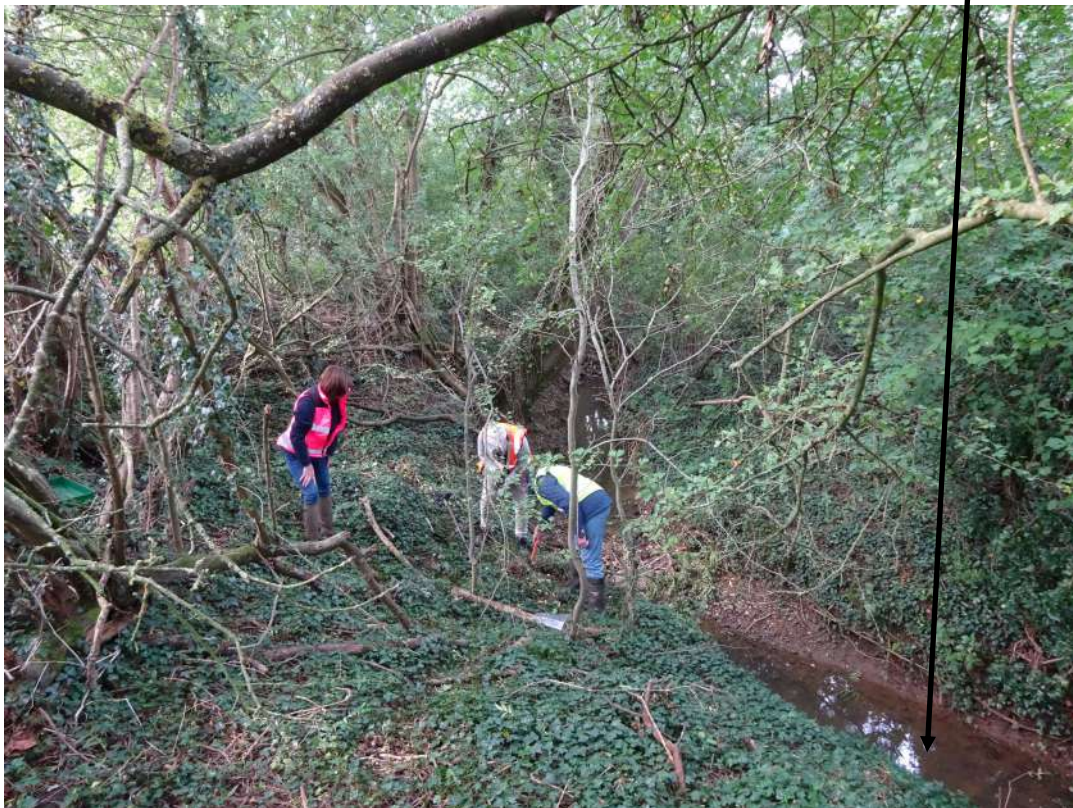
From left to right; Jen, Sophie and Sue examining the remaining aircraft wreckage material on the east bank of the stream, approximately 65 metres north of the footbridge at SK 79149 27916
