# CHURCH FARM HOVERINGHAM NOTTINGHAMSHIRE HALL CLOSE INVESTIGATION

## PHASE B REPORT 2025

## HALL CLOSE INVESTIGATION

CHURCH FARM HISTORIC LANDSCAPE STUDY  
HOVERINGHAM, NOTTINGHAMSHIRE

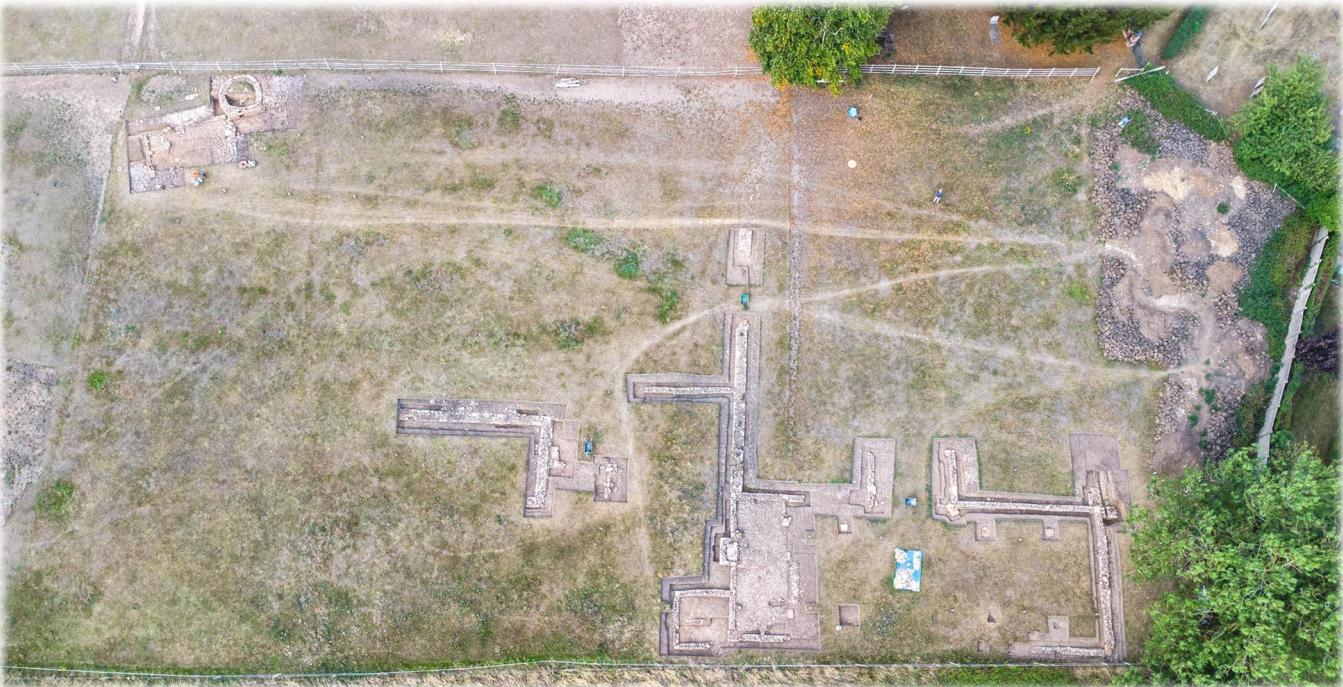
### PHASE B - OVERVIEW, 28TH AUGUST 2025

The image featured below shows the extent of the Phase B excavations at the end of the digging season, 2025.

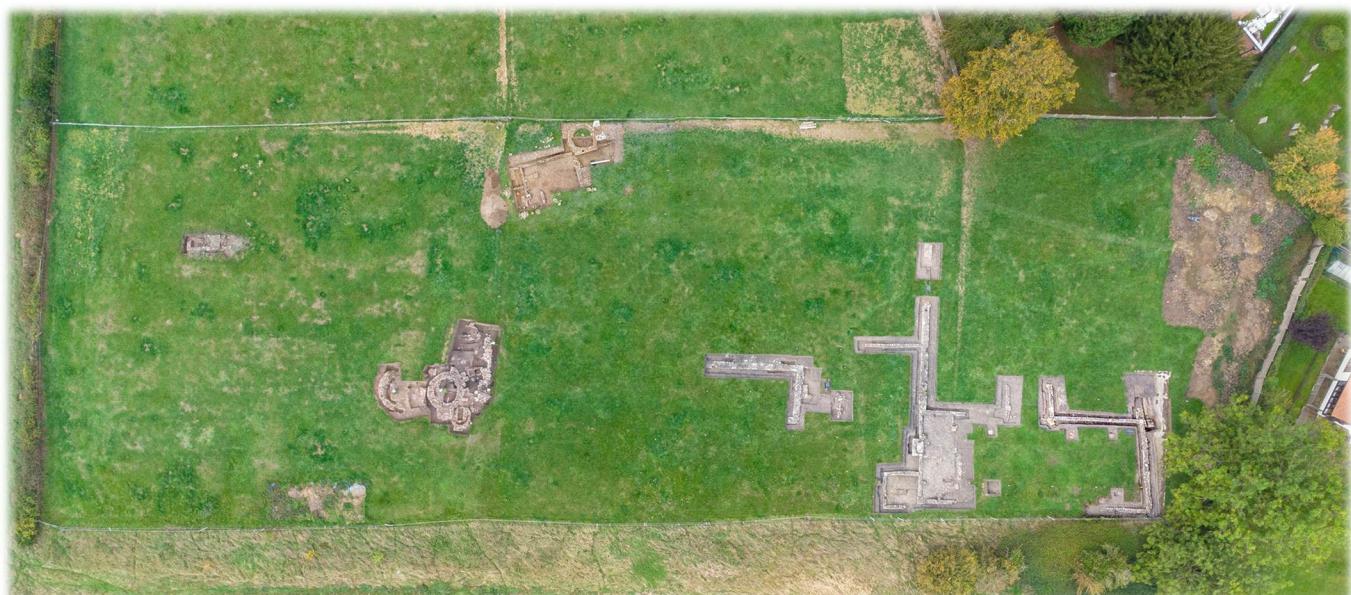
### PLAY SPOT THE HALL

The image below incorporates the Phase A excavations of 2024. As you can see, the site features an extensive range of associated buildings. The big question remains; where is the manor house/hall?

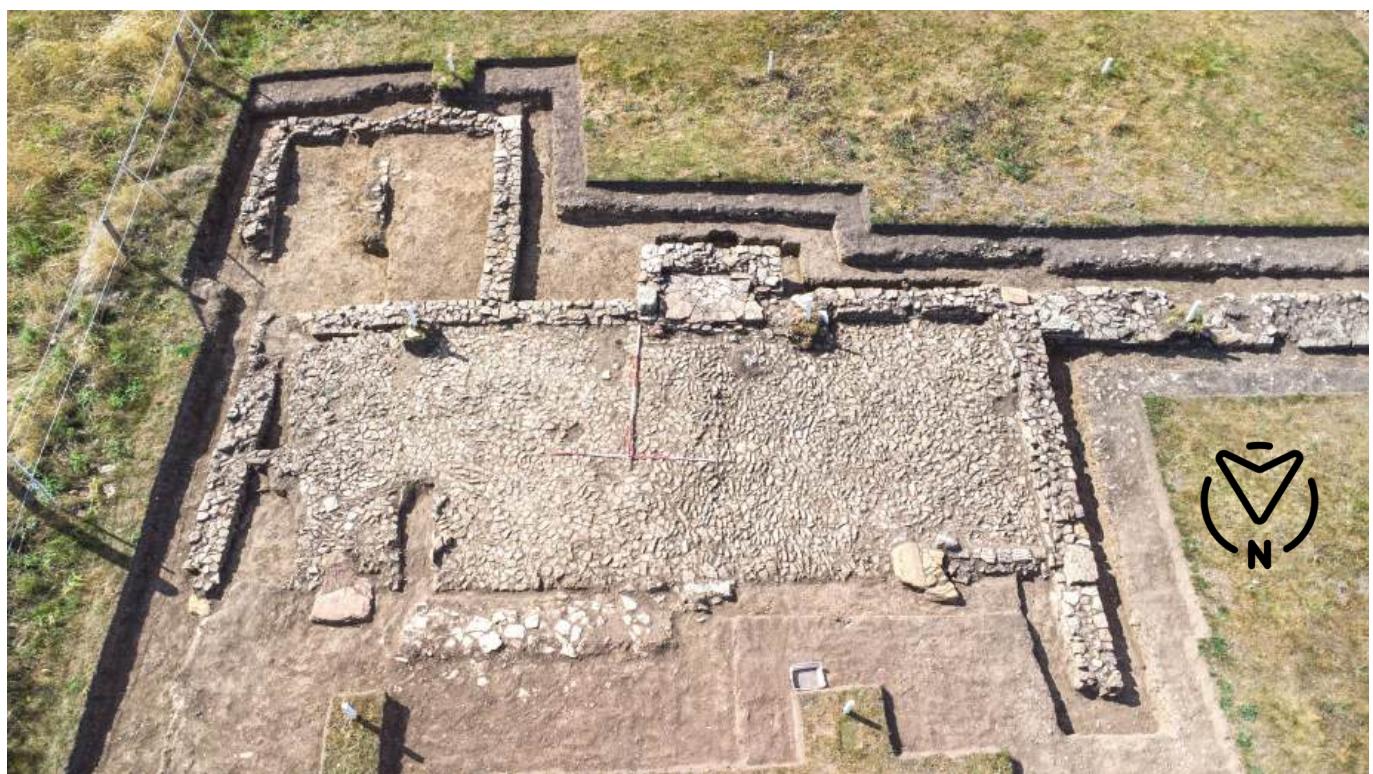
The two images, featured above and below, show the bee bole alcove in the south wall of the Hoveringham medieval barn. There is also an intriguing small room on the east side of the alcove, and the more we take on board the need for a site like this one to be as self-sufficient as possible, the more we begin to consider that the cobbled area in front of the alcove is in some way associated with those ancient practices of self-sufficiency.

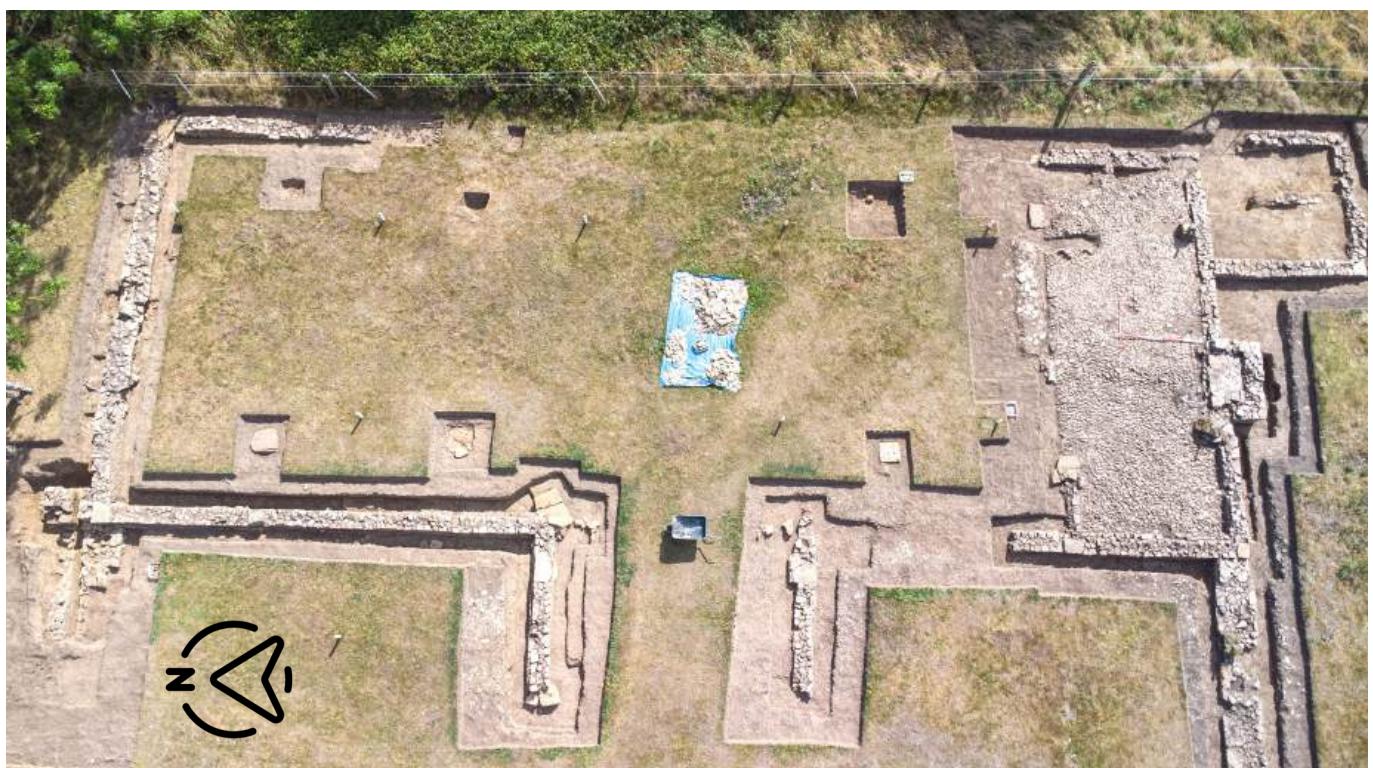
The south-facing end of the barn would have been the warmest place for storage during those long, cold winter months. The 14th century saw the average temperatures cool dramatically. Harsh winters followed; rivers and coastal seas froze over. Crops and livestock were destroyed; heavy and prolonged rains spoilt harvests, unleashing widespread hunger and hardship. Welcome to the beginning of The Little Ice Age - Brrrr.

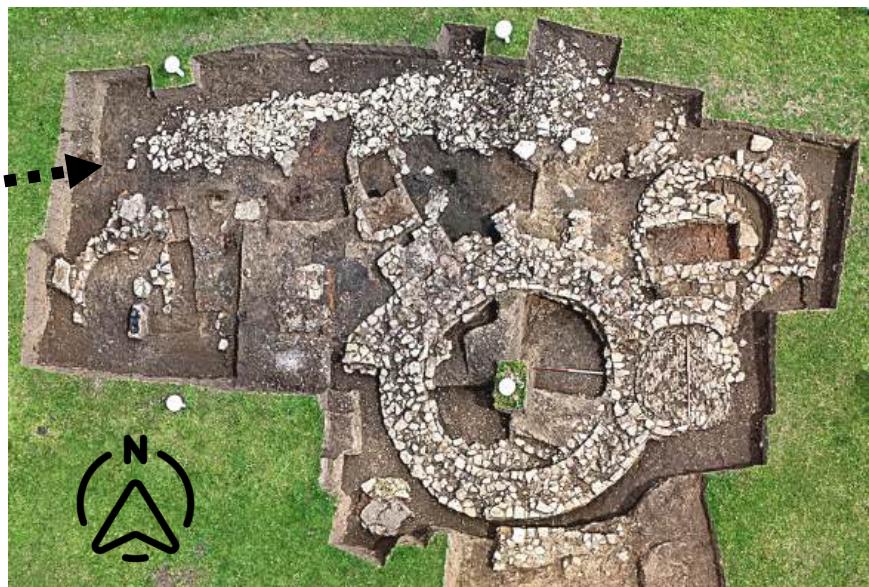
Note the image of the Phase A circle excavation from 2024. The long line of roof furniture to the north of the circle indicates the strong possibility that it was piled here ready for salvage.

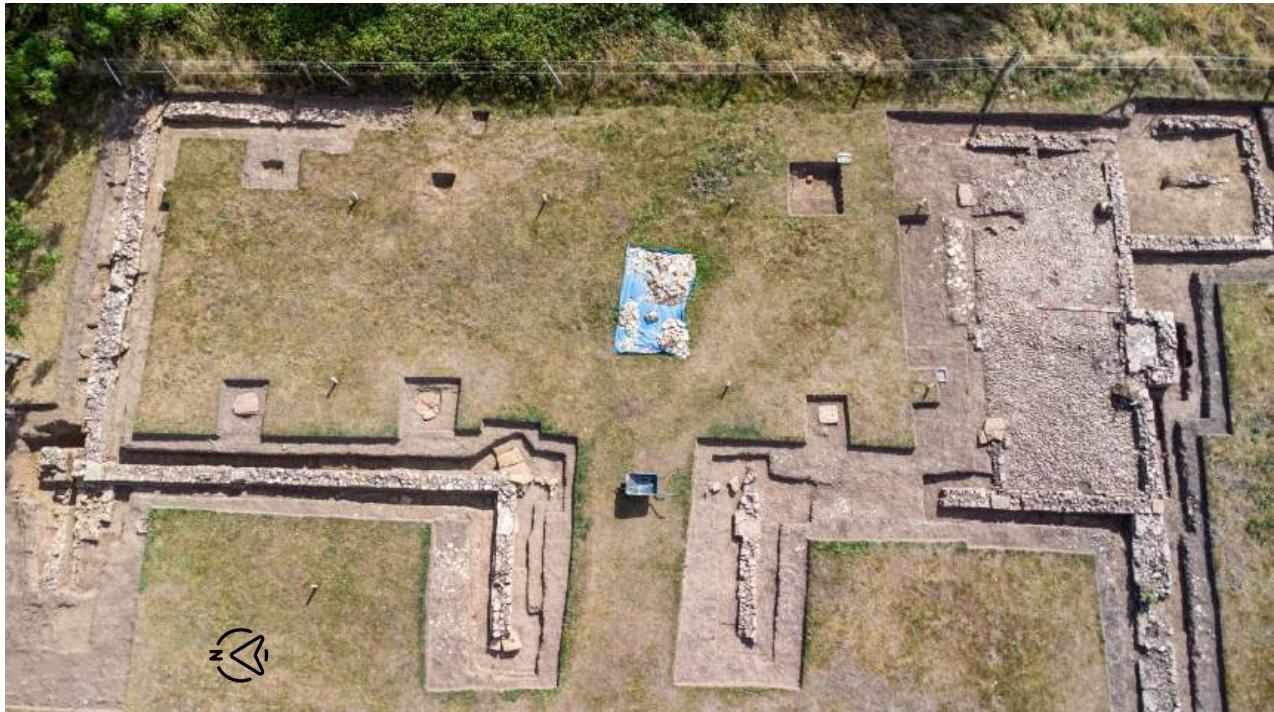
## AISLED BARNS

Aisled barns vary in plan. The most common type has an aisle at each side, but in some cases only one side is aisled and in others, the aisle returns around one or both ends, the construction being similar to that of side aisles. All aisled barns must have at least one porch or raised doorway to allow access for loaded wagons.

The barn here on Hall Close field at Hoveringham, based on our excavations to date, would appear to feature an aisle running down the inside of the west side of the barn and along the edge of a cobbled floor at the south end of the barn. There doesn't appear to be any evidence of an aisle running down the east side or along the north end of the barn, although further investigation is required before we can confidently state that this is the case.

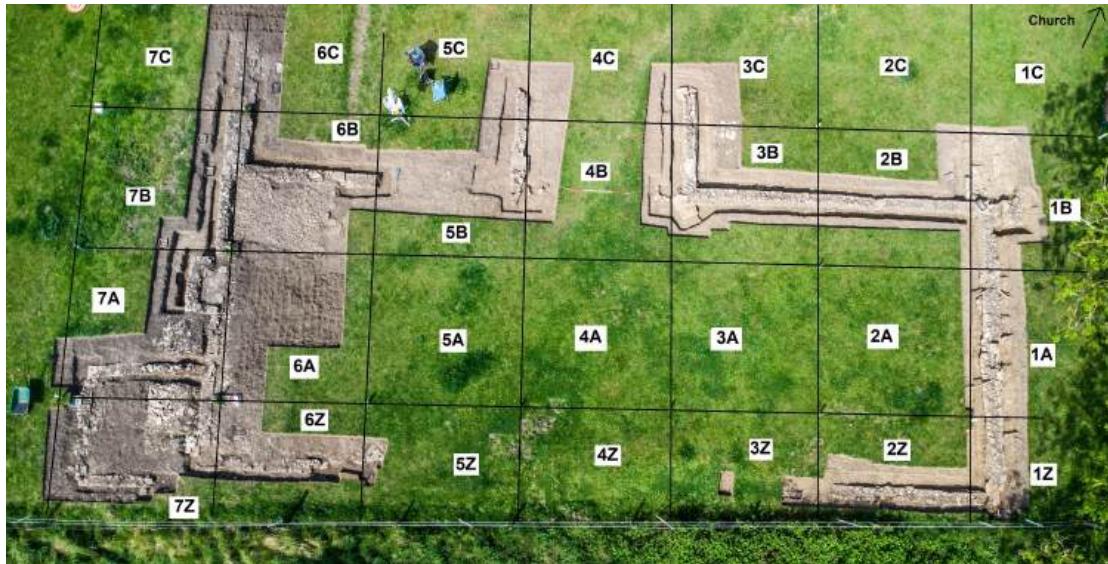
Excavation began in the paddock closest to the church on 10<sup>th</sup> August 2024, over an anomaly in the geophysics. The same grid as the geophysics grid was used to record the archaeology, with 0.0 being the NE corner. 5m grids were given alphanumeric designations, such that the E – W line went from A to H, the S – N line went upwards from 1. It later transpired that the archaeology extended further eastwards, this column was designated Z.

A wall was excavated, extending E-W, this then turned S in grids 1Z and 1C. The wall in 1Z petered out in grid 3Z, while the wall in grid 1C continued to the end of grid 3B where it turned westward for 6m. All this area was designated Trench 1. Trench 2 was opened to look for the continuation of the eastern wall, but no structures were found so it was closed down. Two 1m<sup>2</sup> test pits were opened west of the wall, but no archaeology being apparent they were closed down. Large sandstone blocks were found at the corners of the wall, which otherwise was made up of skerry, a local stone. A matching wall was exposed in grids 5B and C, but no return was found in grid 5B. We believe this to be the entrance to a large barn. Further excavation south of this area revealed the corresponding wall of the barn in grids 6B, 7Z to 7B, and 6Z. At some point the southern wall was modified to incorporate a fireplace, in grid 7A. It may also be a Bee Bole for overwintering hives. From this point west and north was designated Trench 3, including the fireplace, the wall east and north was designated Trench 4. During excavation of grid 5B, 6B it became clear that part of the wall had been robbed out. Westwards from the SW corner of the barn a wider but shallower wall extends through grids 7B to 7F, and continues on the same line in grids 7G to H (Trench 5), we conclude this to be a gateway. In grids 7Z and 7A there is a small room built on to the end of the barn, with a possible entrance on the east side. This has not yet been fully excavated, but contains a large amount of Midlands Yellow pottery at approximately 80cm below turf level, these sherds are from one pot. The southern section of the barn has a laid surface, and on the western side of the barn there are 5 stylobates. One has been located at the edge of the surface on

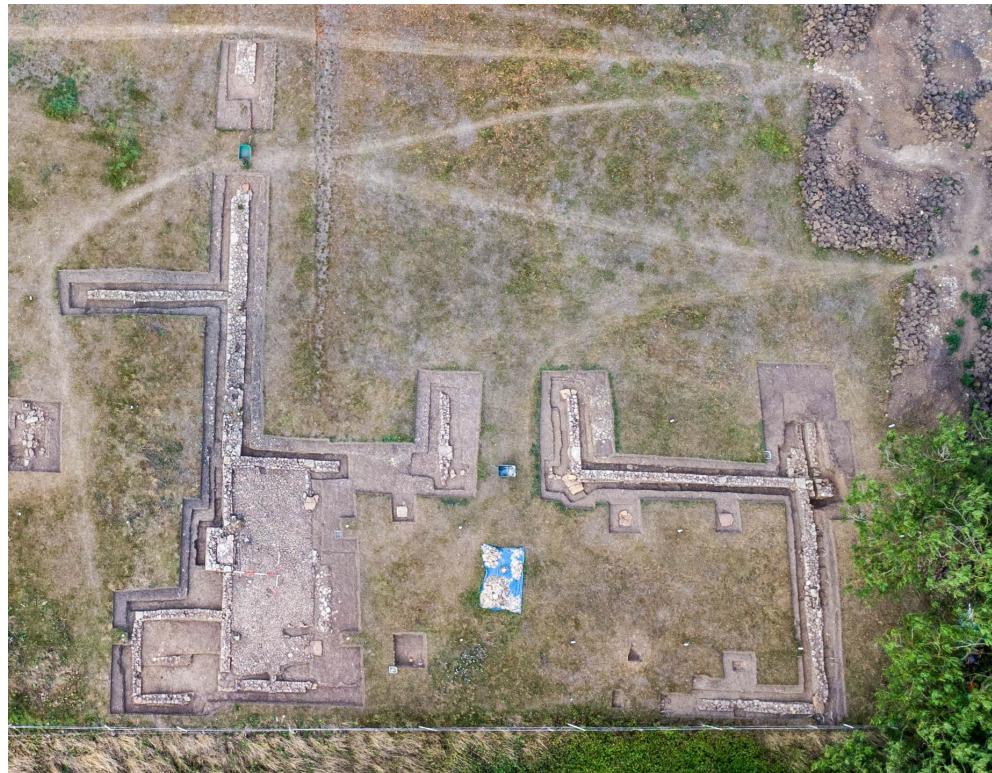
Aerial view of barn

the eastern side, but no others have been found in situ, though they may have been lost over time. While cleaning for drone photographs a 1m wide wall was uncovered below the level of the barn walls in grid 1B. The trench was extended around this corner of the barn and designated Trench 7, Trench 6 being the 'Circle' located in H16 approx (see report by Peter Duke). Excavation showed this to be part of a mill race, with structures in line with the barn wall to support the axle of a small wheel.

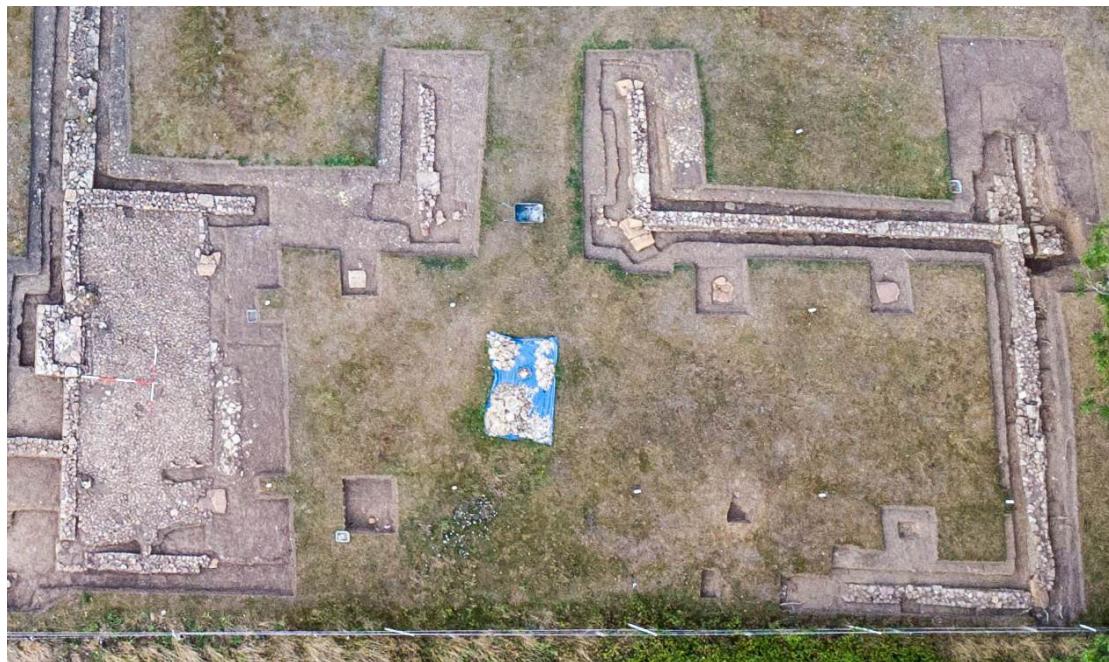
**Comparison of Hoveringham and South Witham barns**

The structure of the barn is two rows of four post footings (stylobates) made of sandstone. The footings on the west side are still in place but only one of the east side is fully in position with another possible remnant. The footings have some regularity with the north and south footings around 3.5-4m from their corresponding walls. The other two footings in the row are 4-4.25m from the previous. The footings at the entrance are 10m apart.

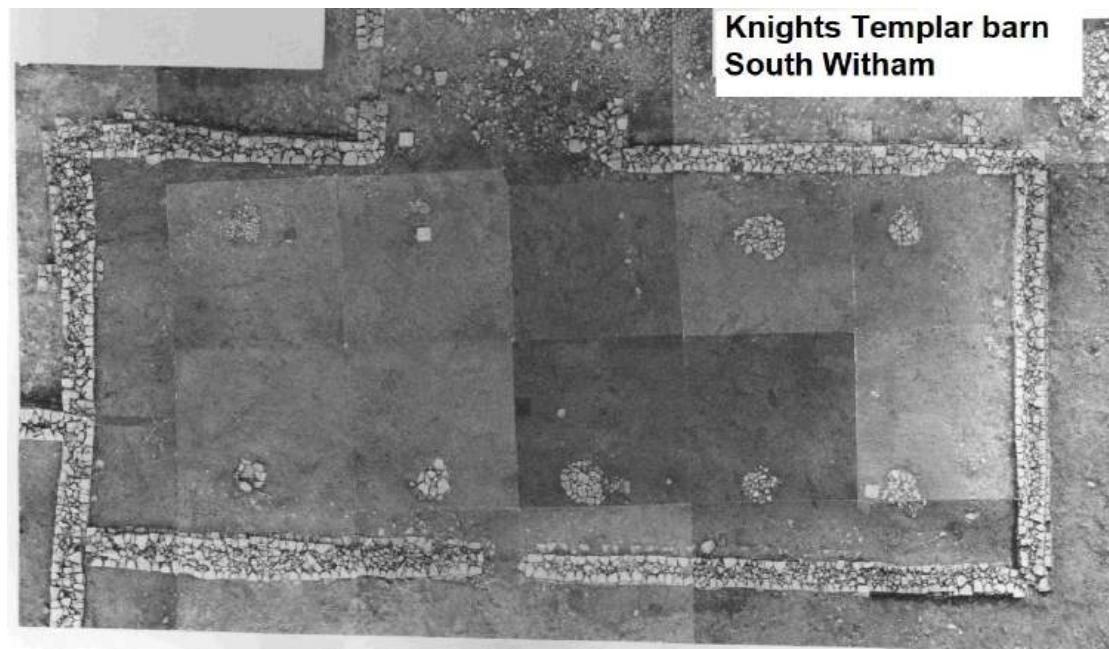
**Knights Templar barn 12-14<sup>th</sup> century 26 x 10.6m**

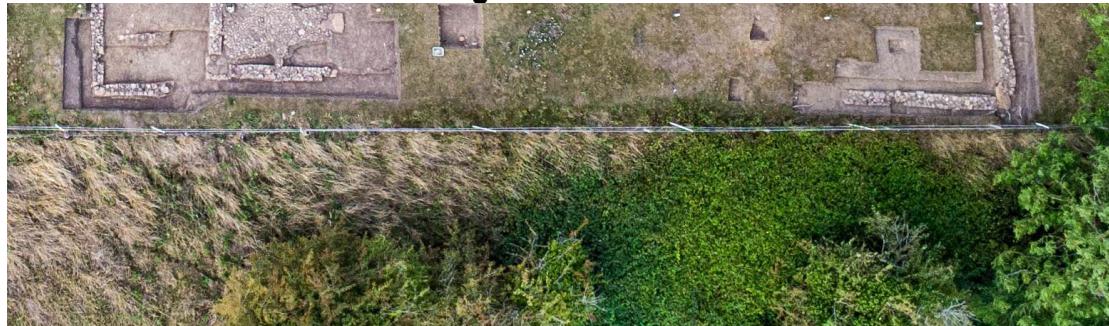
I--Missing section of East wall---

The east wall is missing over 15m of wall, several test pits found no remains of the wall. The site is known for severe historical flooding with the ground to the east of the barn dropping away about 2m, this may mean this section of wall has

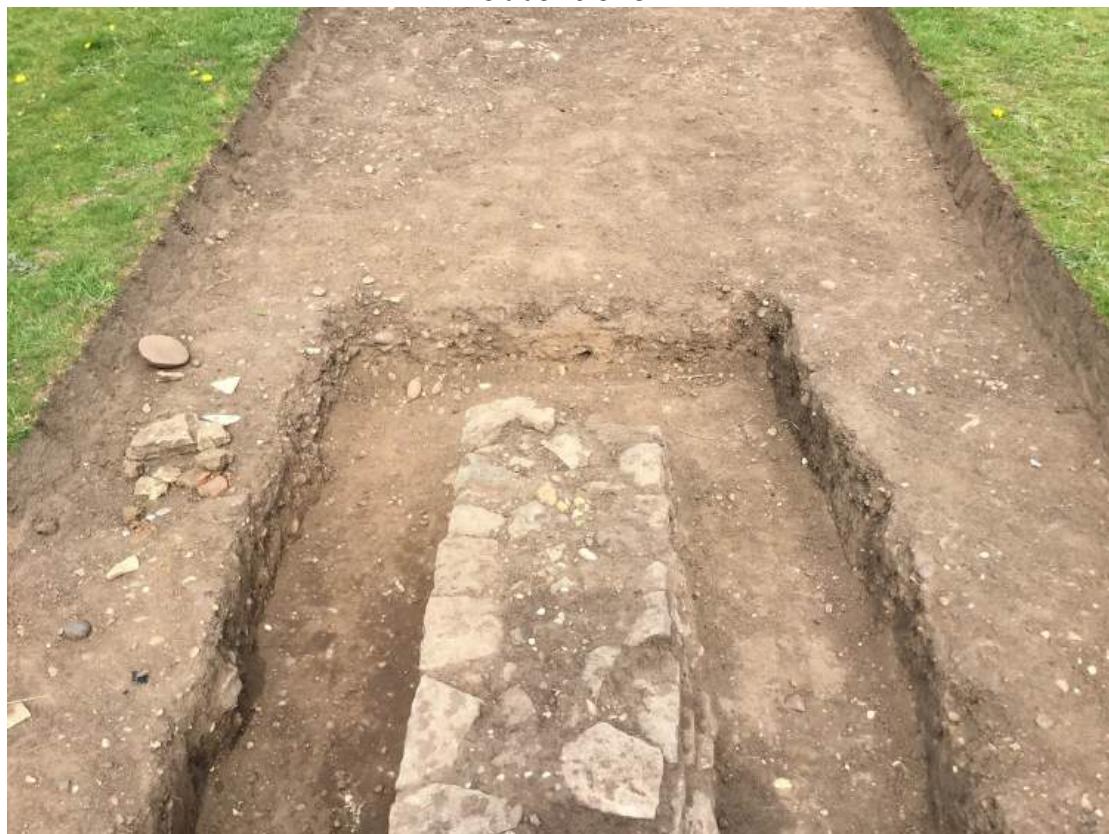
Robber trench

To the south of the entrance part of the wall has been robbed out. It is possible that at a later period only the south end of barn was still standing and the walls were robbed out to make the surface (context 310) and the fireplace (context 313-4) for storage or animal husbandry. This may also account for the missing corner stone at context 406 that is possibly a soak away/sump for animal waste to be washed into.

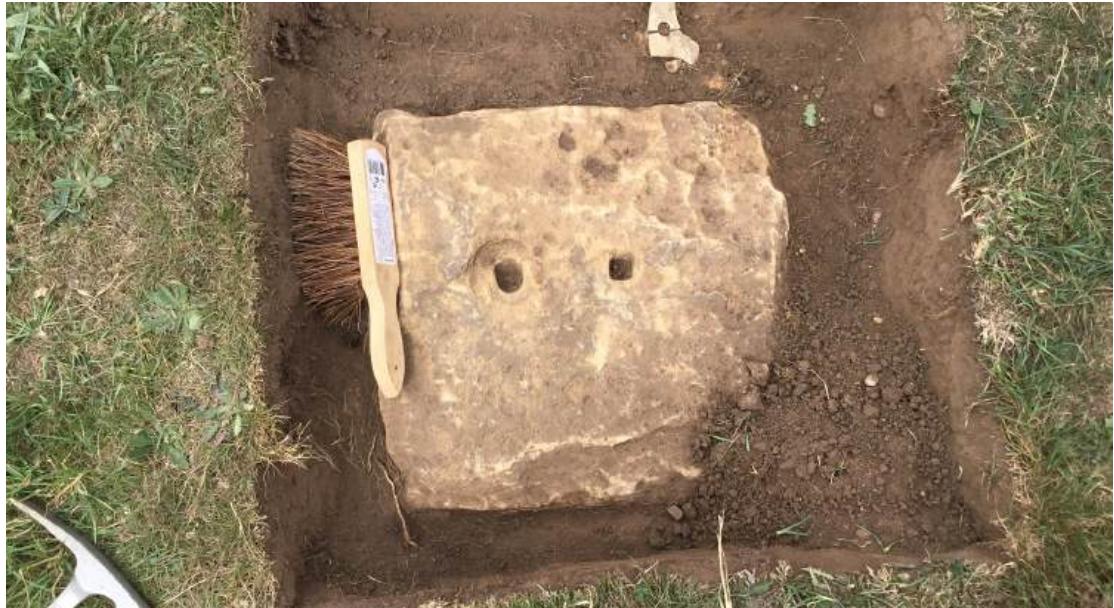
One of the stylobates east of the robbed out wall is different to the rest. It is similar to stones used for horsedrawn railways, if in situ there may have been a small railway for moving sand and gravel. It is also possible that surface 310 is related to that activity, and why both walls are missing in this area. If not in situ, do not understand why stylobate replaced with a 19<sup>th</sup> century stone when barn already out of use.

Replacement Stylobate or part of horse drawn railway?

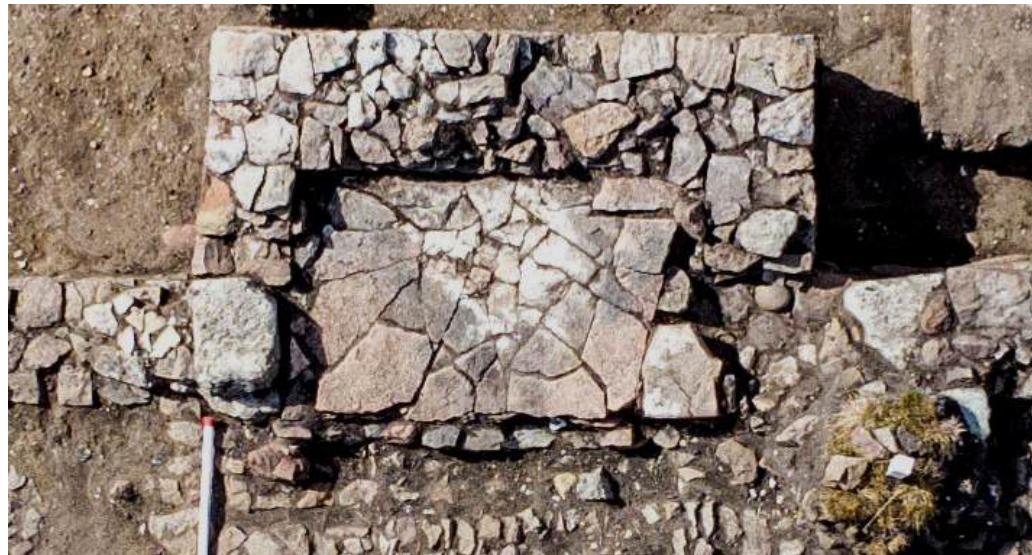
The fireplace has clear areas of burning ranging from orange on the outer edges then black in middle ending in white centre. The fire was not very hot as there was no obvious signs of burning effect on the surrounding wall, only on the flagstones context 314. This possibly indicates the fire was for warmth rather than cooking. This might match in with another idea that it was a Bee Bole for hives hibernating in winter. At the front edge was a run of stones possibly acting as some fire guard. A substantial amount of unusually very light moulded stones was found on the surface.

Fireplace with area of burning

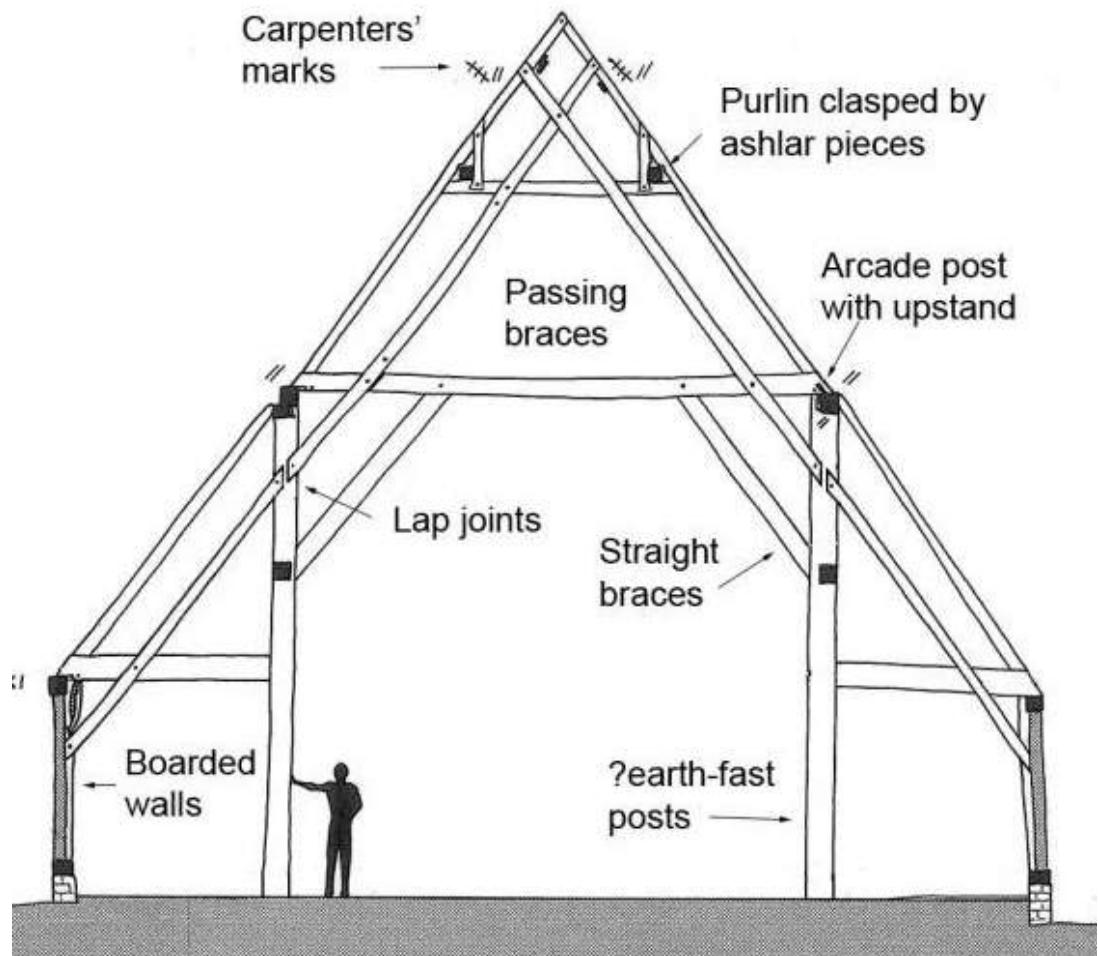
Diagram of construction of an aisled barn

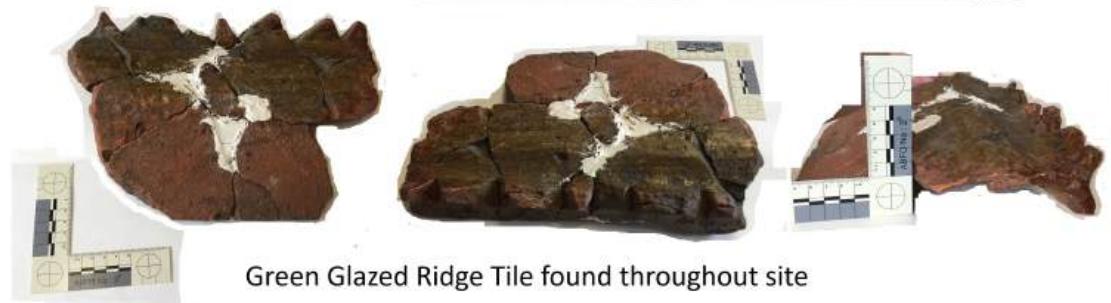
All the walls of the barn have green glazed ridge tiles associated with them, but not recovered in sufficient quantities for the roof span. Most have a dragons teeth design, but a few are different. (30+ Kg)

Green Glazed Ridge Tile found throughout site

Green glazed dragon toothed ridge tile.

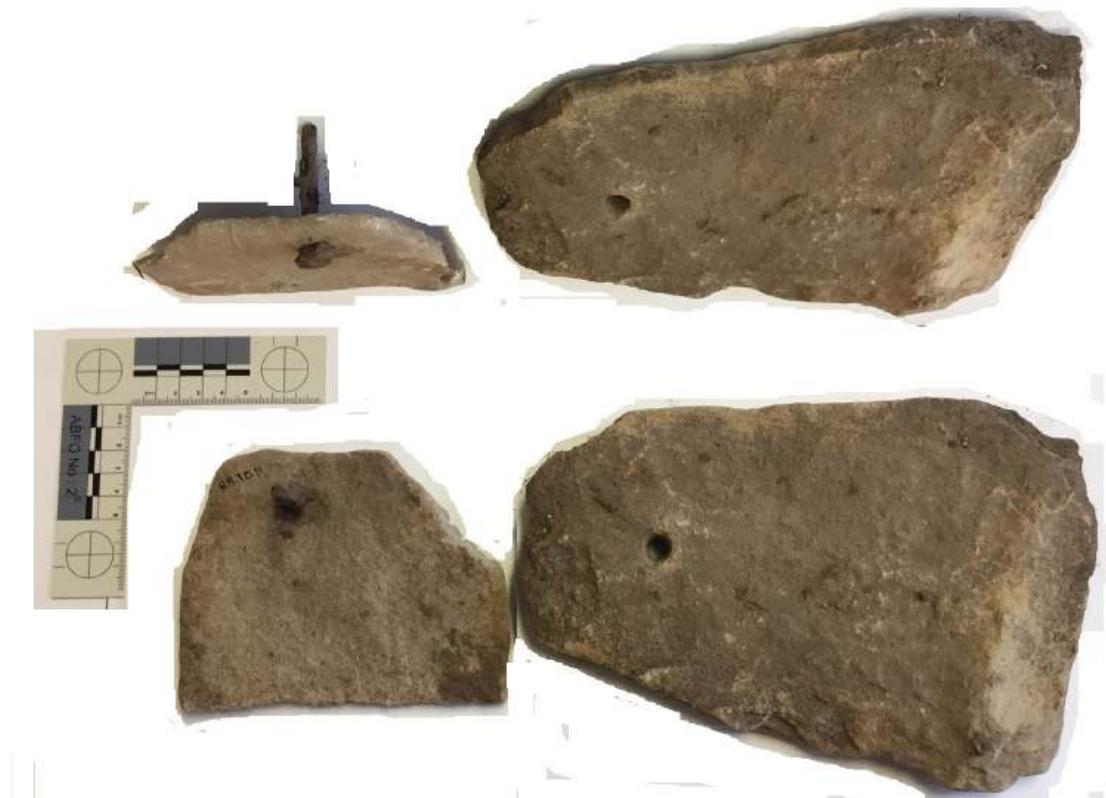
They are often found in conjunction with mudstone roof slates, which seem to be everywhere, though there are areas of concentration. One slate still had an iron nail in situ.

**Mudstone roof slates found throughout site**

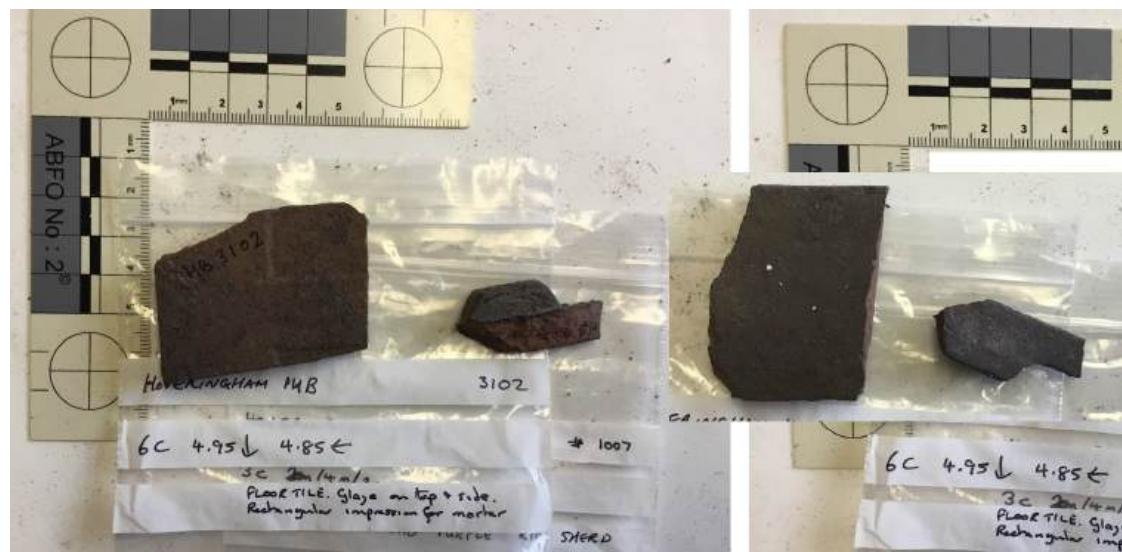
Some fragments of floor tile were found in 7B, which are probably 18<sup>th</sup> century.

**Tile with indents for mortar**

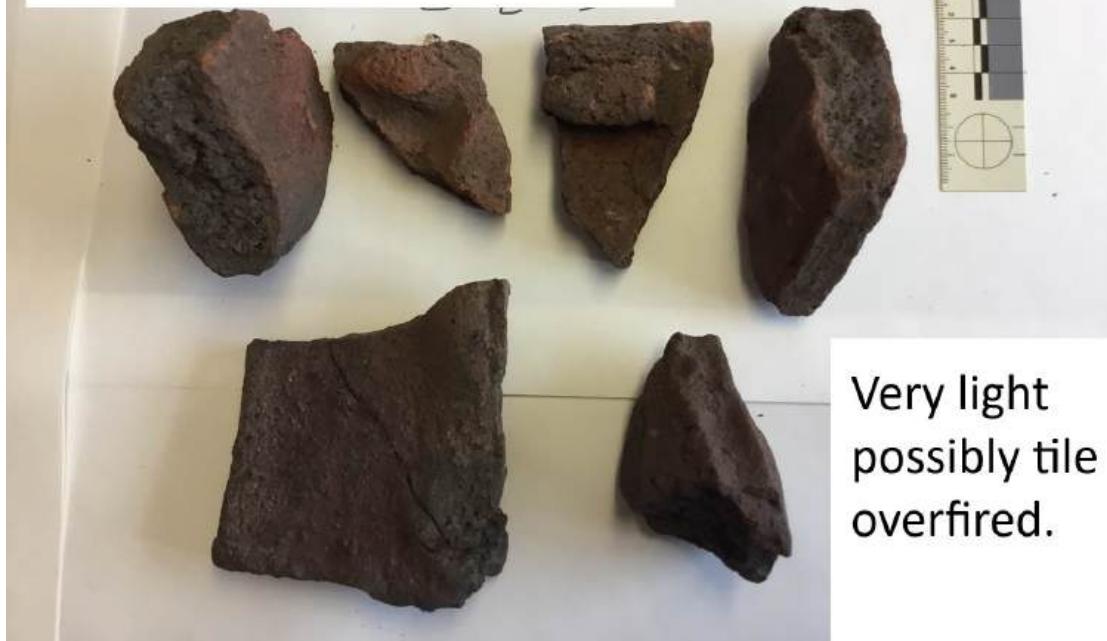
# 3048 50+ pieces 3.2 Kg  
Hoveringham phase B

Also excavated in the region of the fireplace, were many pieces of mis-shaped tiles, very light with honeycomb type fabric. They may be overfired roof tiles, but seem too many to be accidental. It is possible they were part of a decorative feature around the fireplace.

Very light  
possibly tile  
overfired.

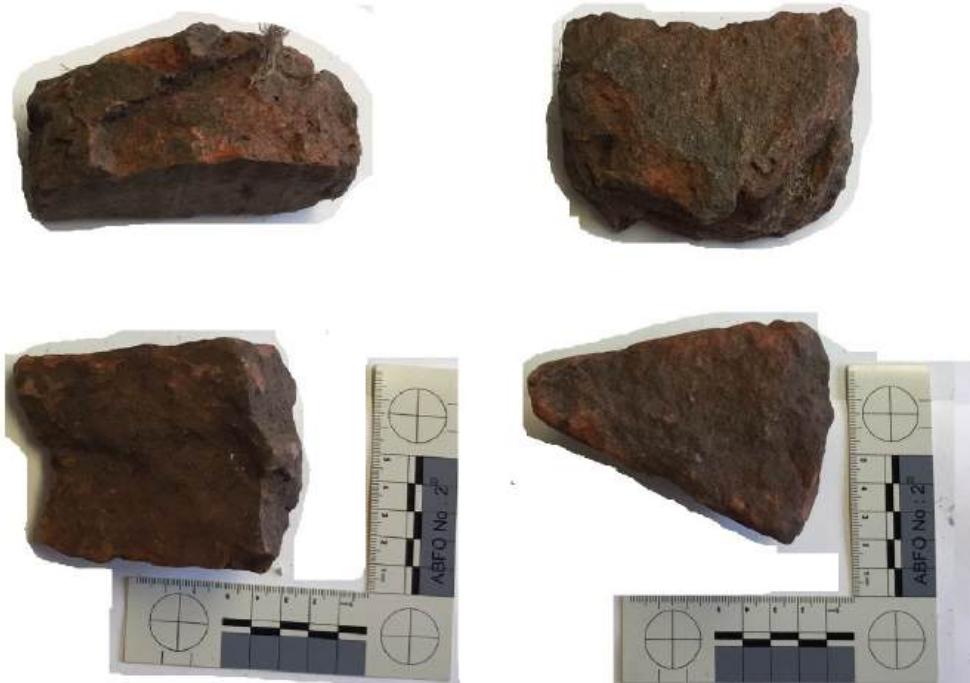
Several bricks were found, near fireplace, one of which was wedge shaped, possibly for an arch.

From grid B6/7 near fireplace possible keystone for arch.

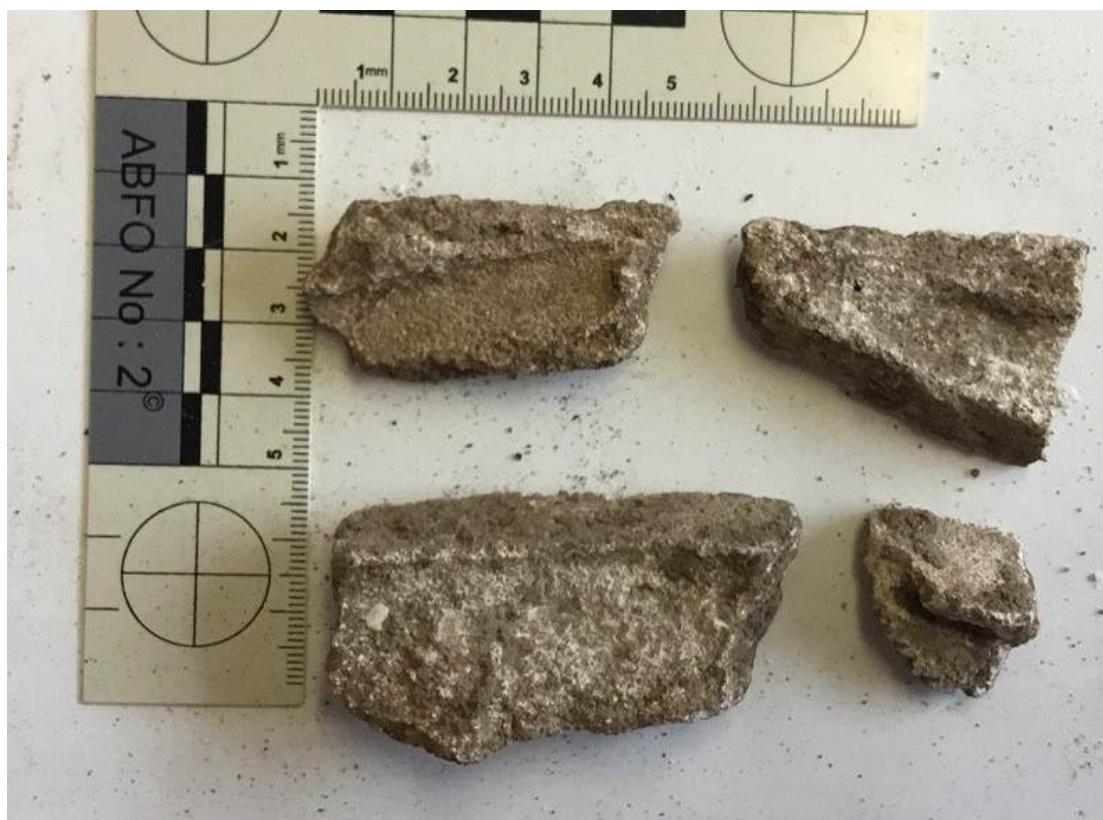
Mortar/plaster was discovered by the fireplace, still attached to the wall, and large chunks were found in the small room. This was shaped as if from a reed ceiling or lath and plaster wall.

## #4041 Lime mortar showing reed/ lath indentation

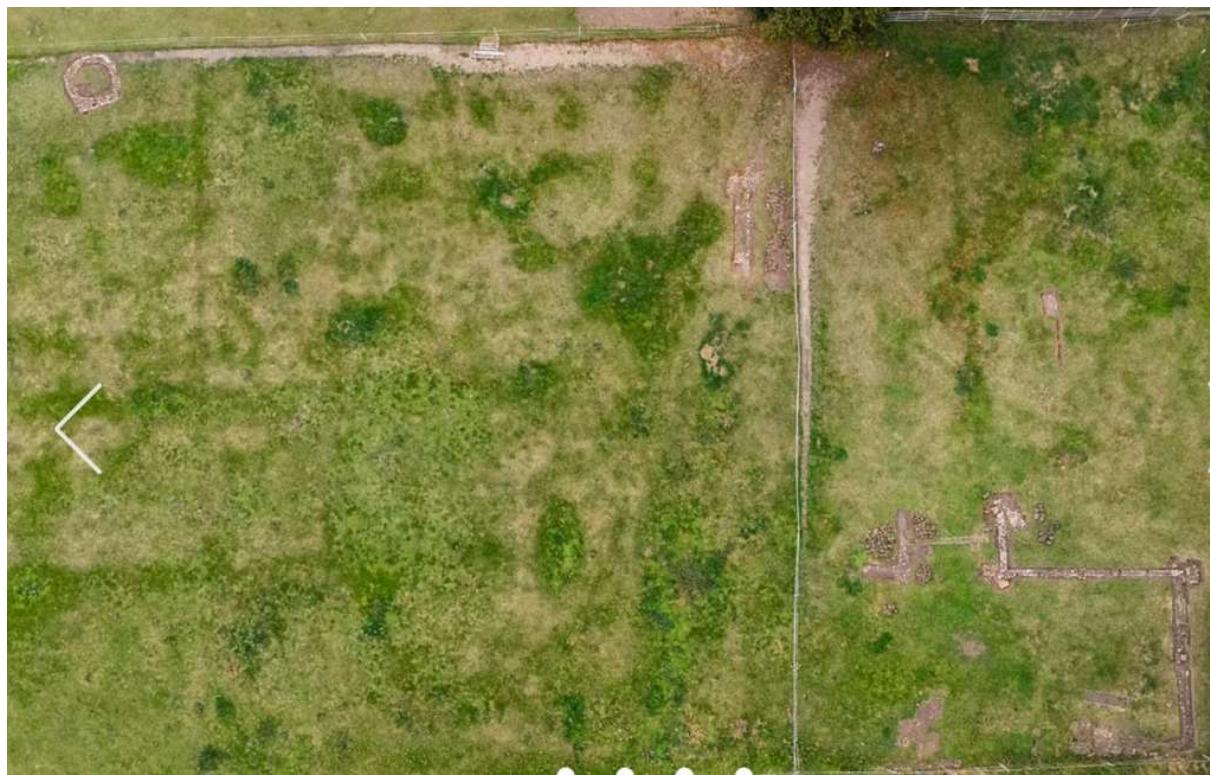
A drone shot 19 September 2024 showing the circle top left after phase one excavation and the 'barn' bottom right.

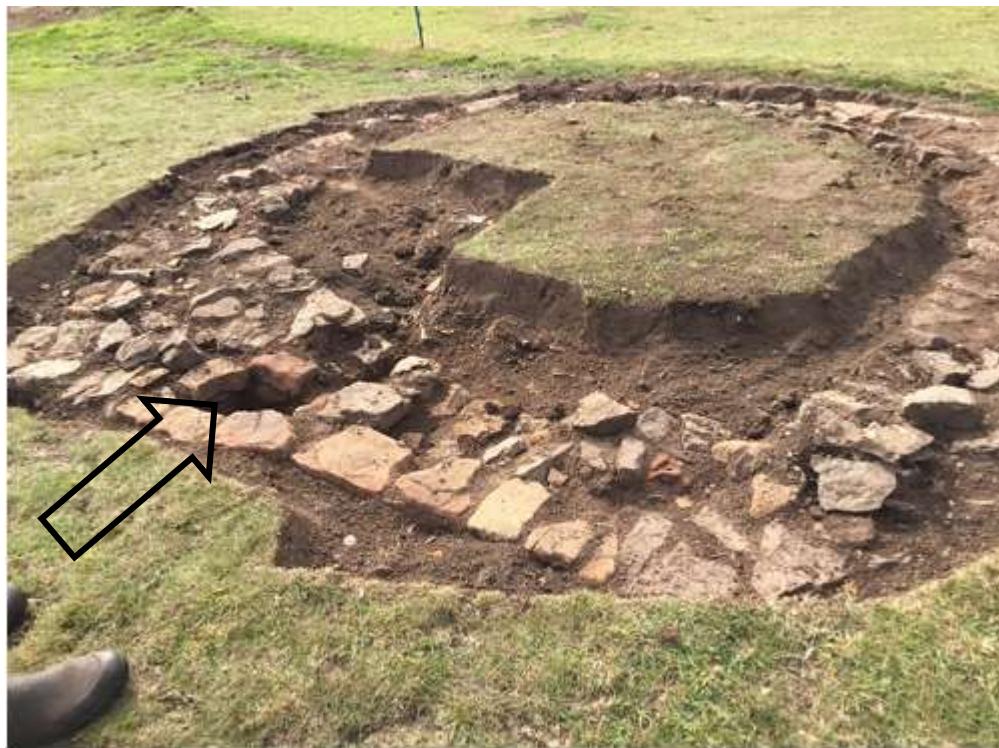
Arrow pointing to the void in the wall, looking West.

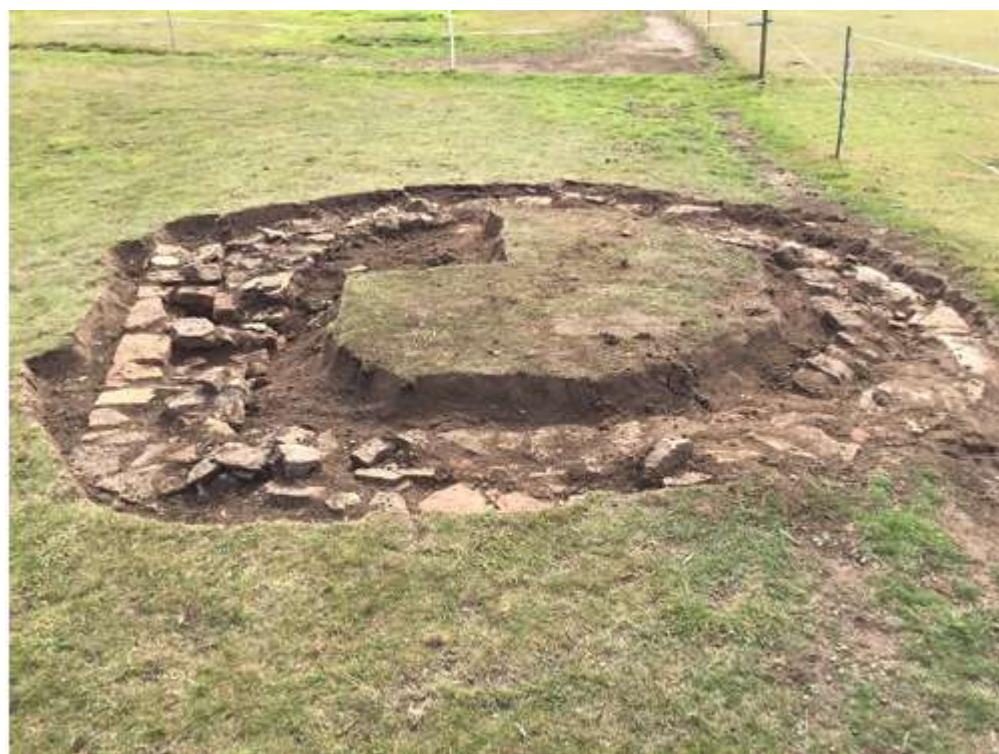
Phase one complete, looking South

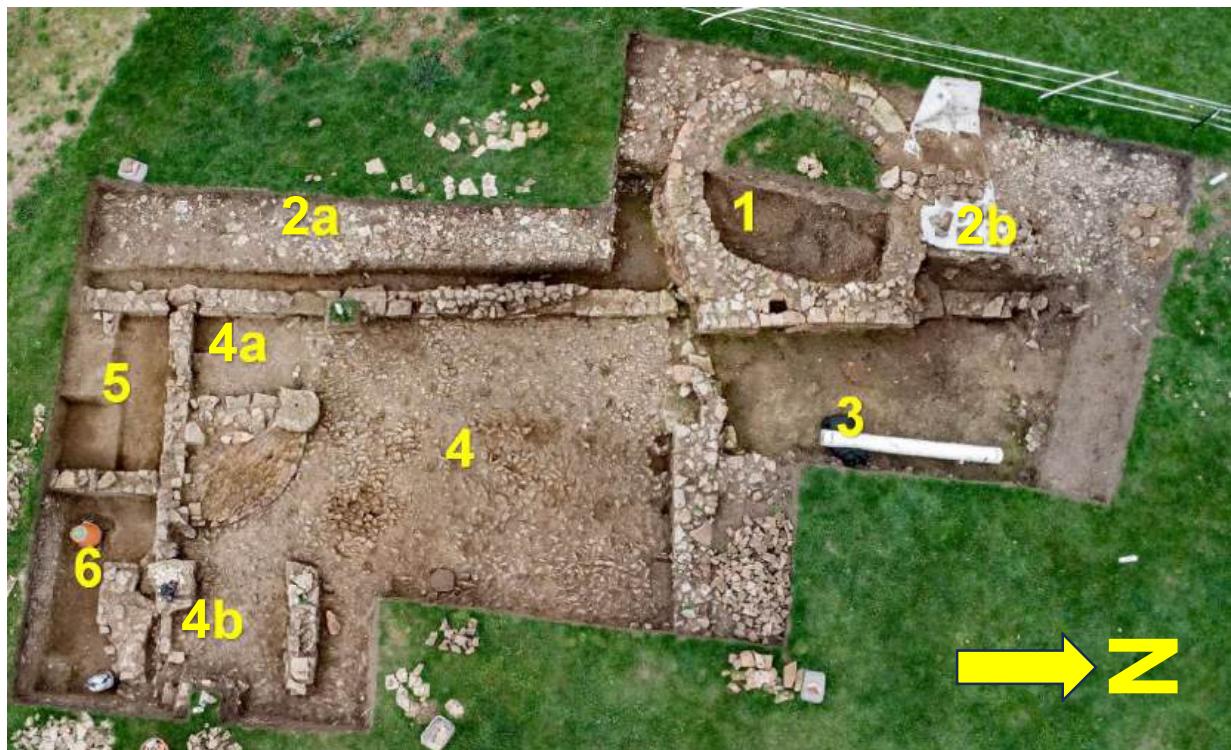
A plan of the circle excavation shortly before backfill in October 2025 showing area numbers mentioned in the following interim report

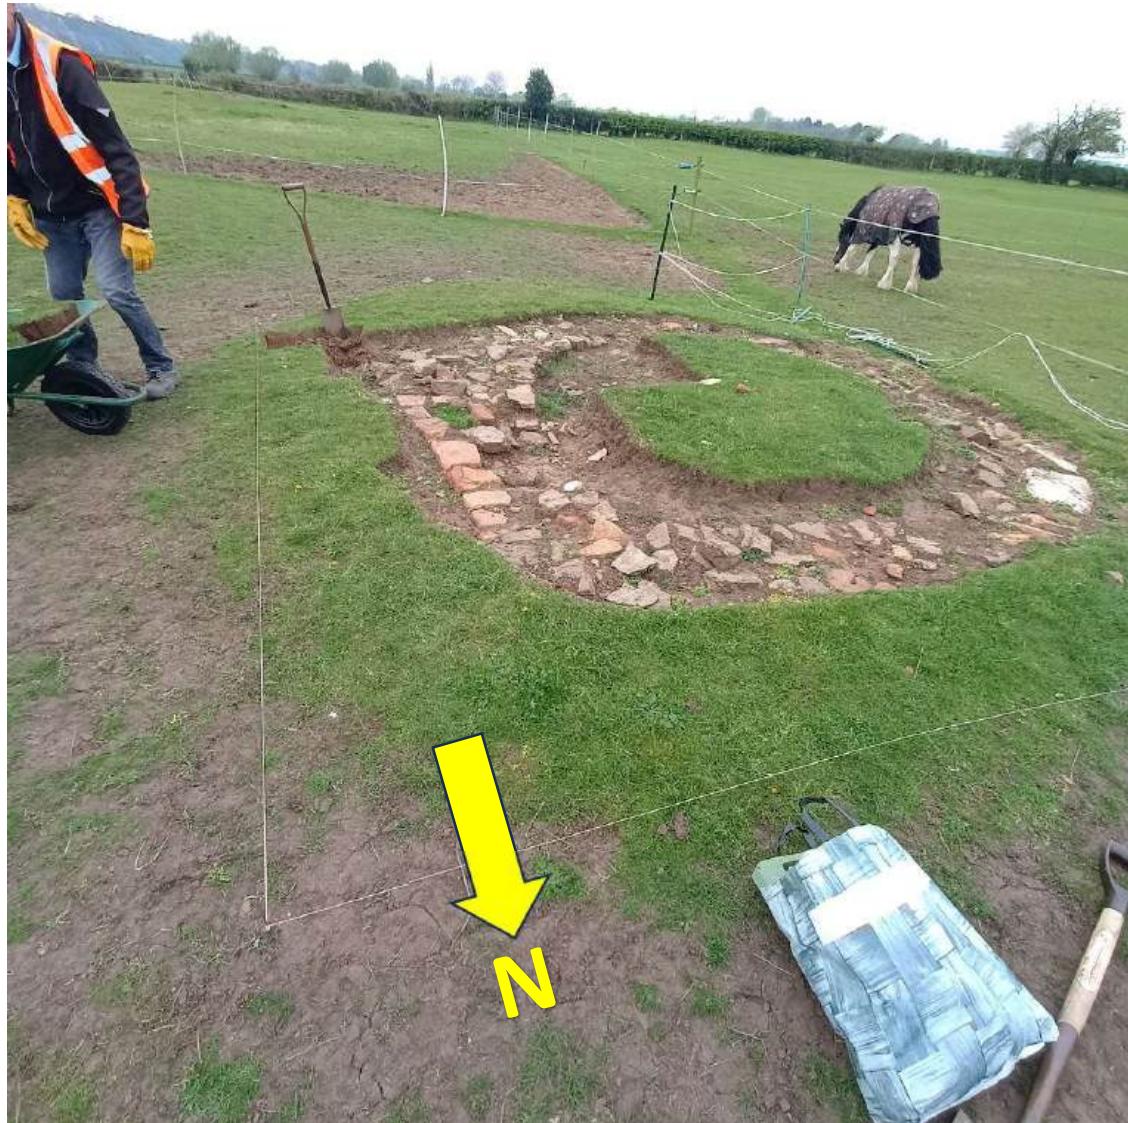
The first turf is cut

The marked out square measures 4.6m on the southern side, 4.6m on the eastern side (where Roger is standing) 4.9m on the western side and 3.76m on the northern side owing to the close proximity of the fence.
