# CHURCH FARM HOVERINGHAM NOTTINGHAMSHIRE HALL CLOSE INVESTIGATION

## PHASE B REPORT 2025

## HALL CLOSE INVESTIGATION

CHURCH FARM HISTORIC LANDSCAPE STUDY  
HOVERINGHAM, NOTTINGHAMSHIRE

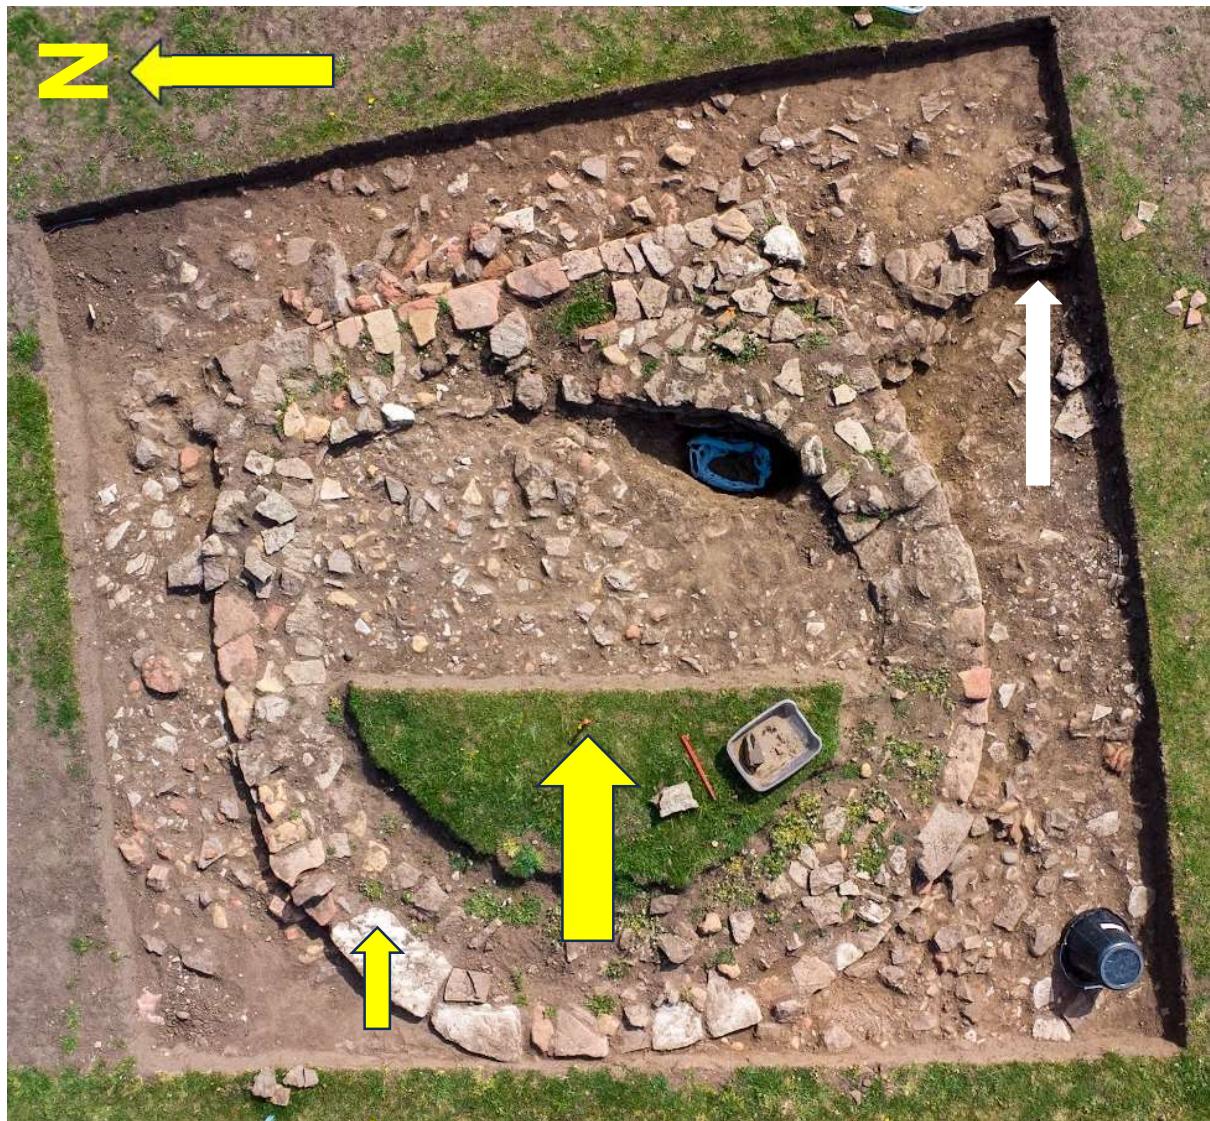
A robber trench (white arrow) running North/ South. The large yellow arrow points to a red dot which is the datum peg used to calculate the levels. The peg top is 210mm above this corner of the large white skerry stone shown by the small yellow arrow. It was decided to half section the circle interior as quarter sectioning would be too confining.

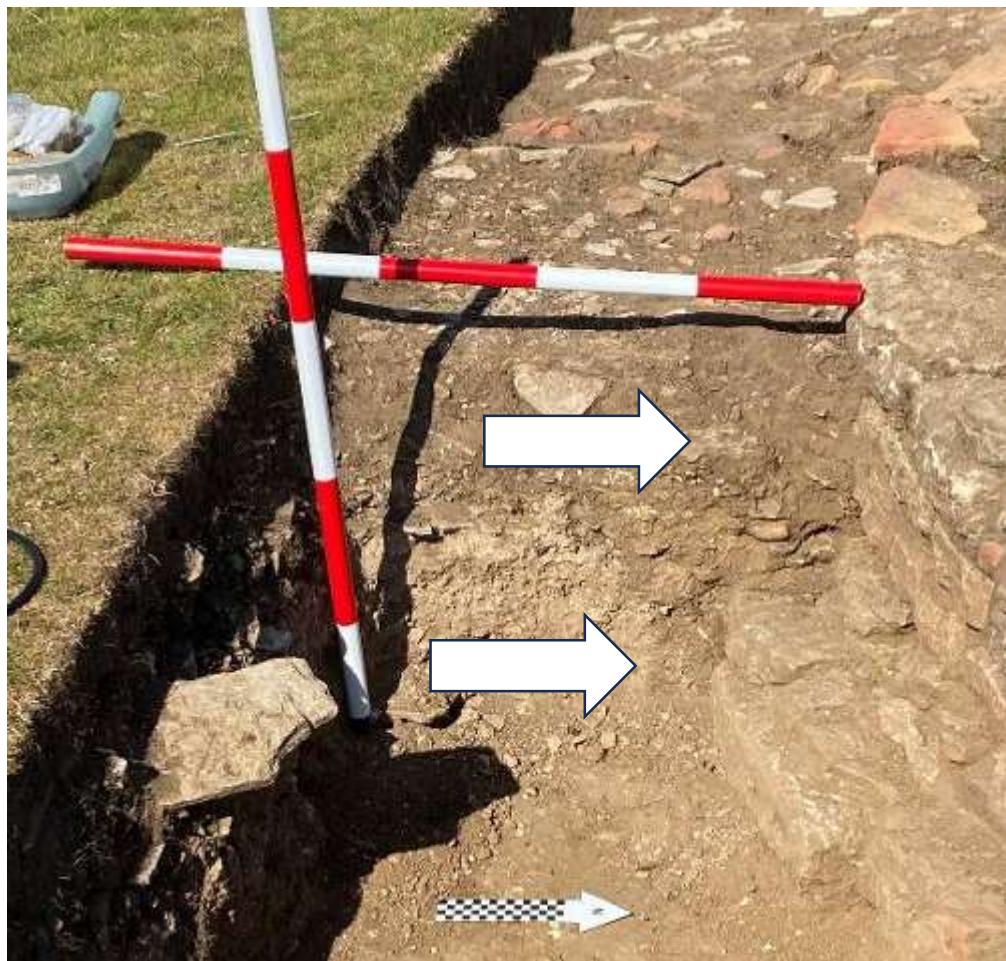
The south wall of the circle looking west. The white arrows point to the building trench cutting through the rubble. The rubble consists of crushed mortar, stone, skerry roofing tiles, plain terracotta roofing tiles, glazed ridge tiles, bones, nails & 13/14<sup>th</sup> century pottery.

The same rubble layer extended under the south wall and through the circle itself. It will make the dating the circle tricky.

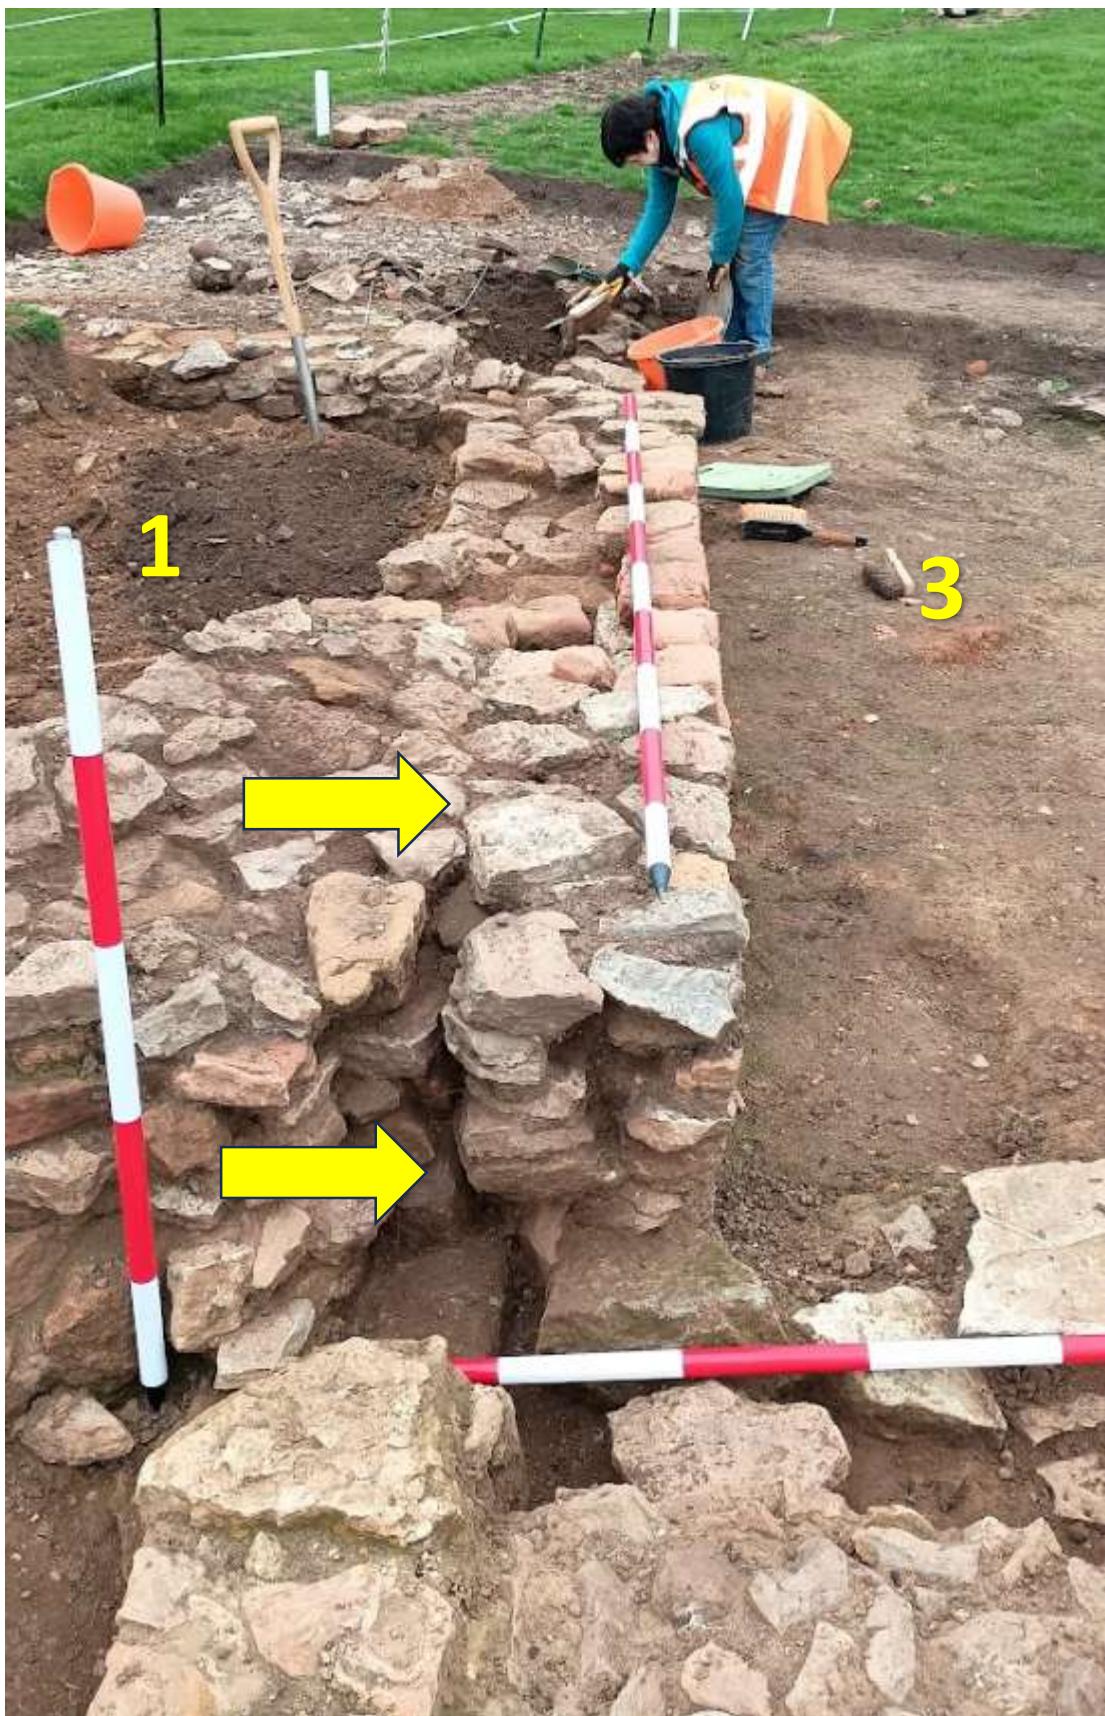
The circle (1) may have been constructed in two stages as there appears to be a fault line as shown by the arrows.

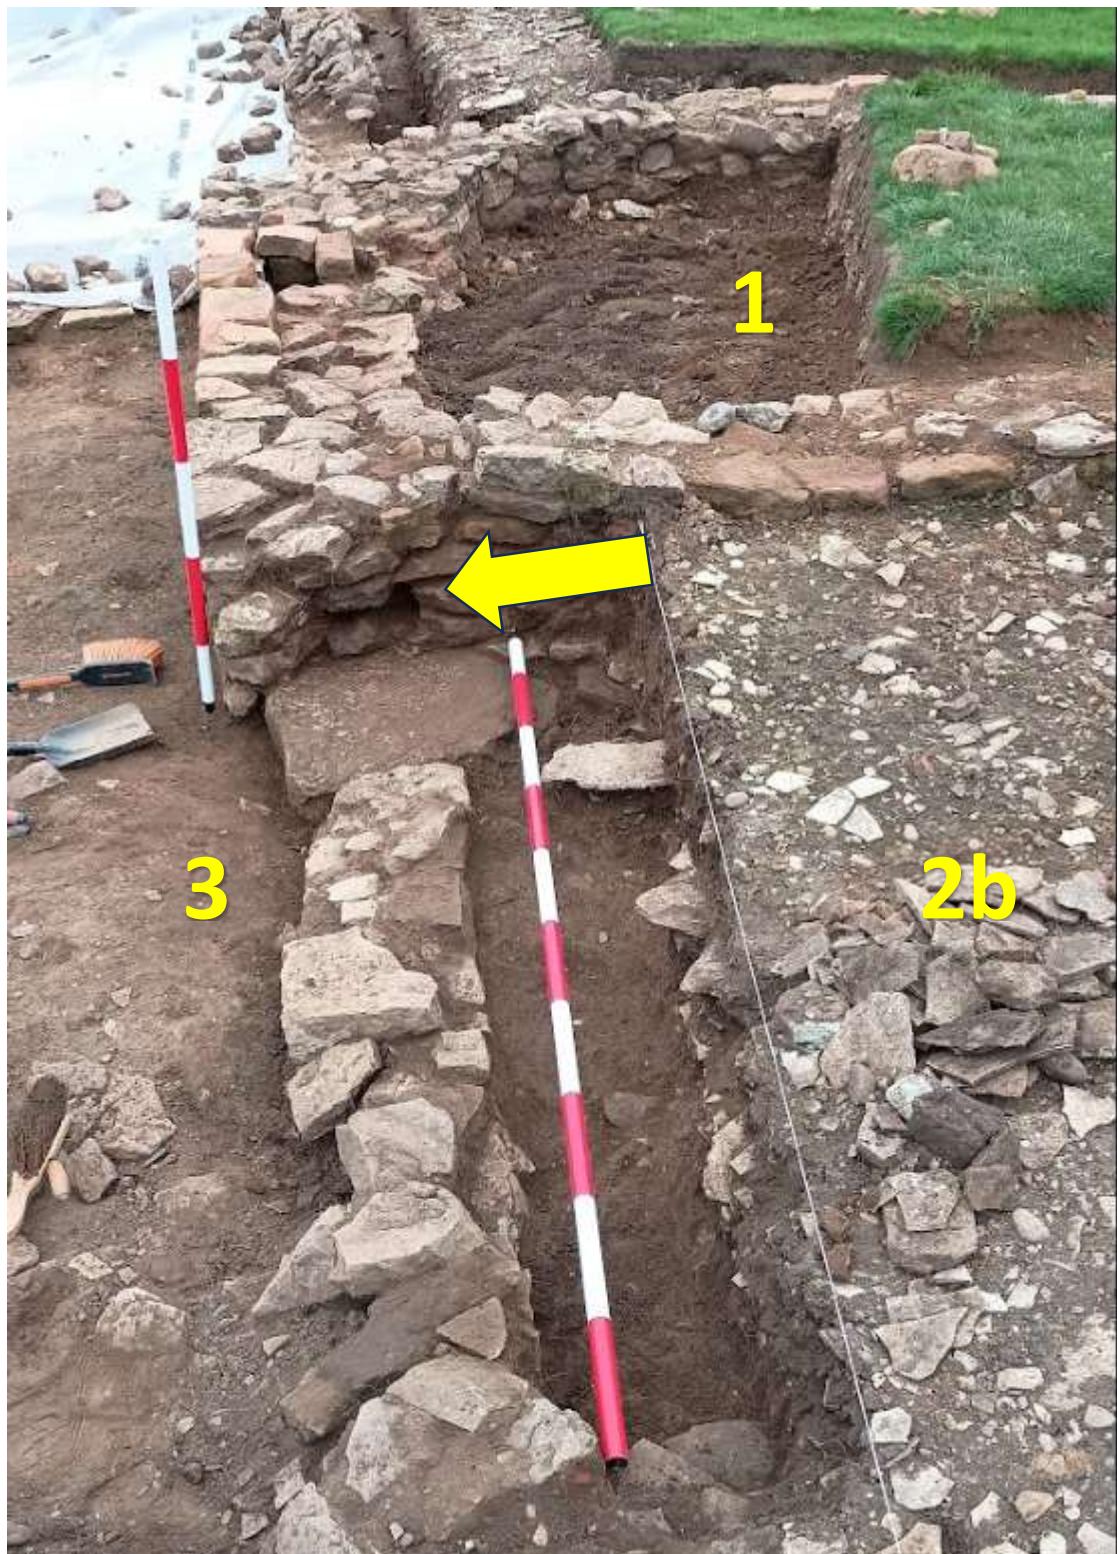
The fault line is less defined on the opposite side of the circle so it may be just a building error. The wall running north/south next to the ranging pole runs under the flat face of the circle.

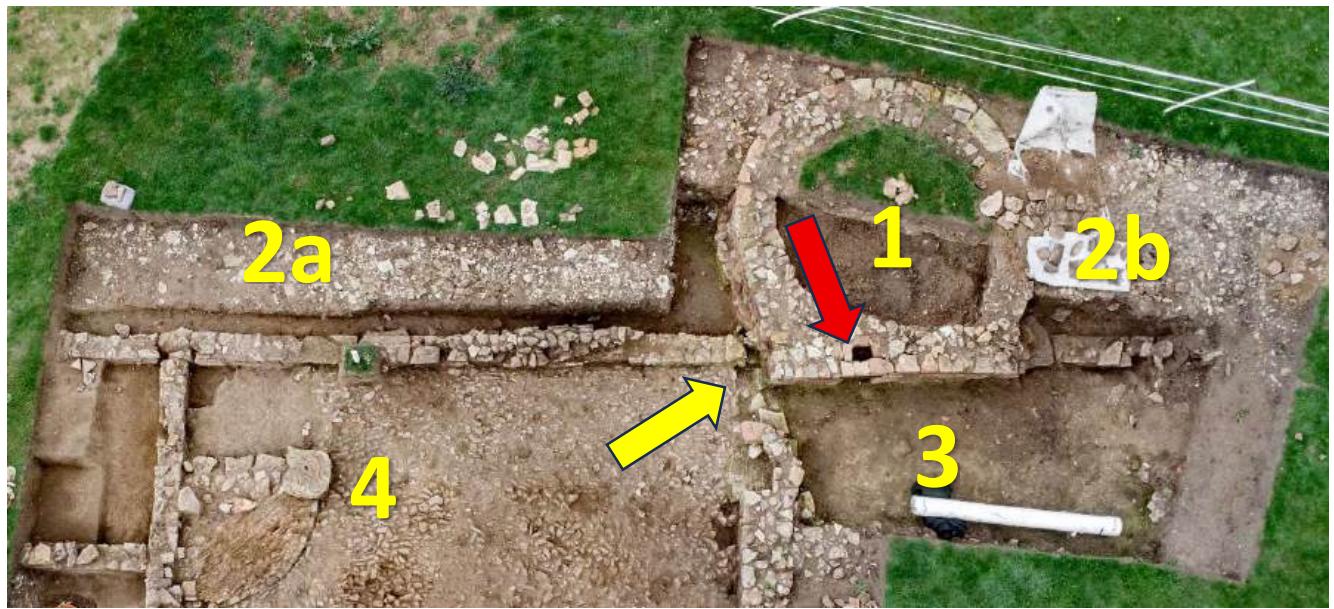
The circle is built on top and cuts through the north/south wall and the east/west wall as indicated by the yellow arrow. It's also not quite on the same alignment. The red arrow points to a flue hole below which is a stoke hole.

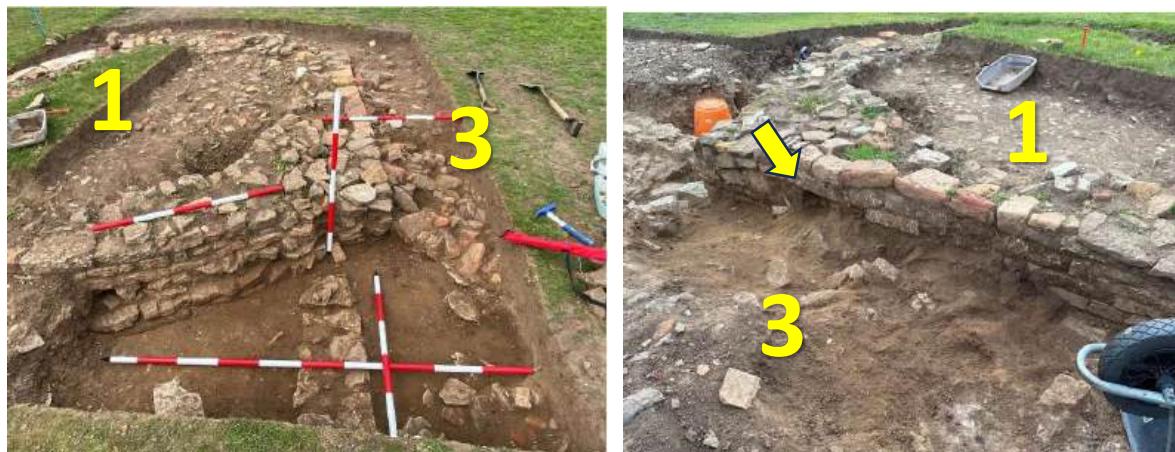
There was heavy demolition in area 3 in front of the circle (left). Having stripped away some of the rubble, the lintel above the stoke hole, indicated by the yellow arrow (see above right), was fractured in three places (see below left). As it was unstable it was numbered and temporarily removed to facilitate the safe excavation of the stoke hole (below right).

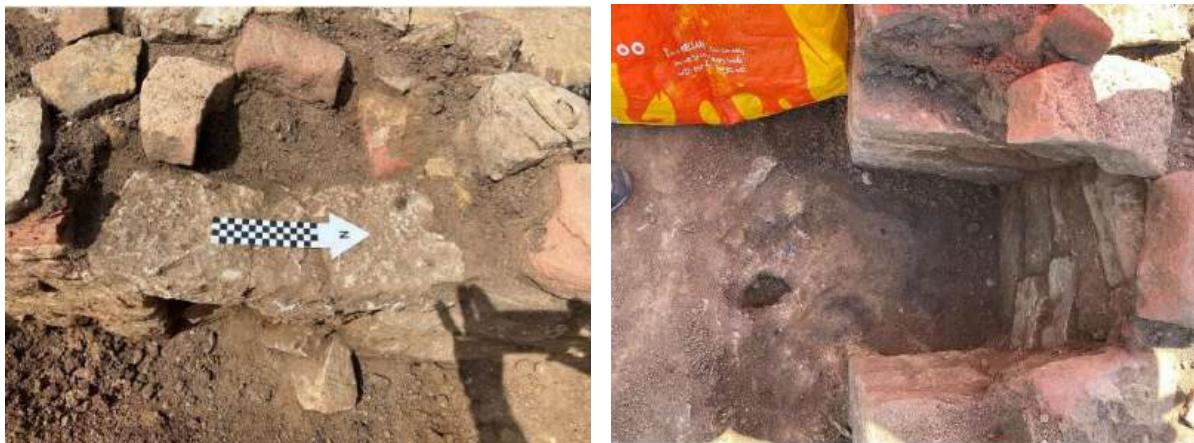
The stoke hole contained soil and sand with a few broken charred stones. At the bottom were four deeply charred boulders.

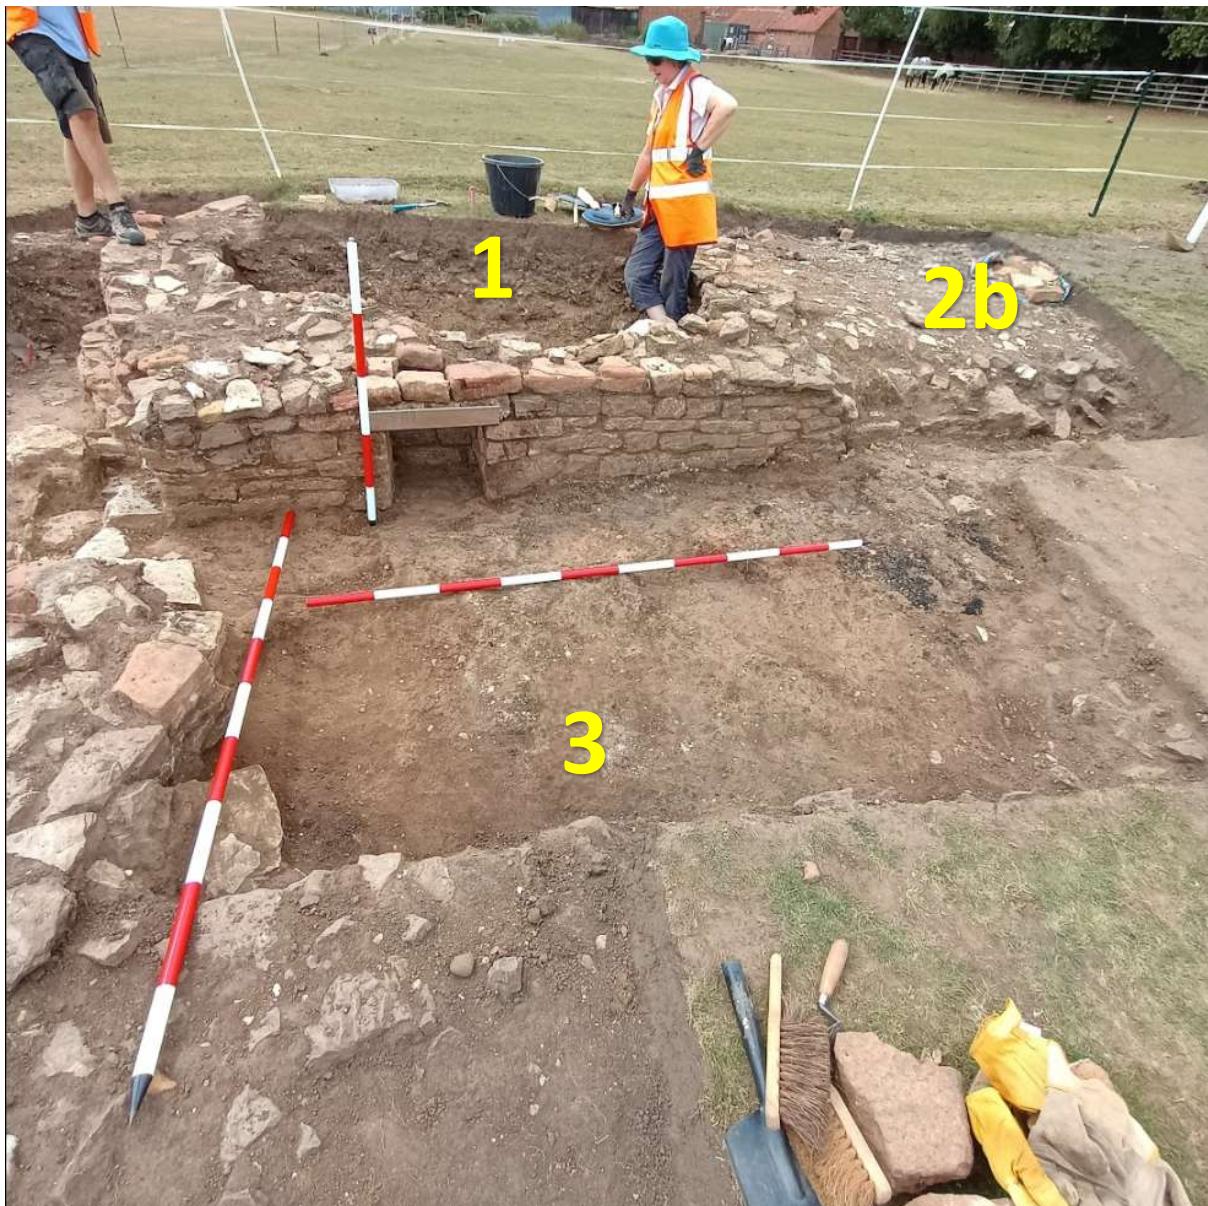
The lintel above the stoke hole was returned when we had finished excavating that sector and was supported by stainless steel. Note how the demolition in 2b falls over the wall into area 3.

In front of the stoke hole there had been intense burning which extended over the whole of area 3. This may have been due to hot ash being raked out of the stoke hole. There was no intense burning in area 1 at all. Unfortunately, area 3 became too hard to dig due to the hot weather, so it was decided to stop at this point and resume next season. Note how the rubble in the top left of the left hand picture cascades over the top of the north/south wall (yellow arrow) from area 2b.

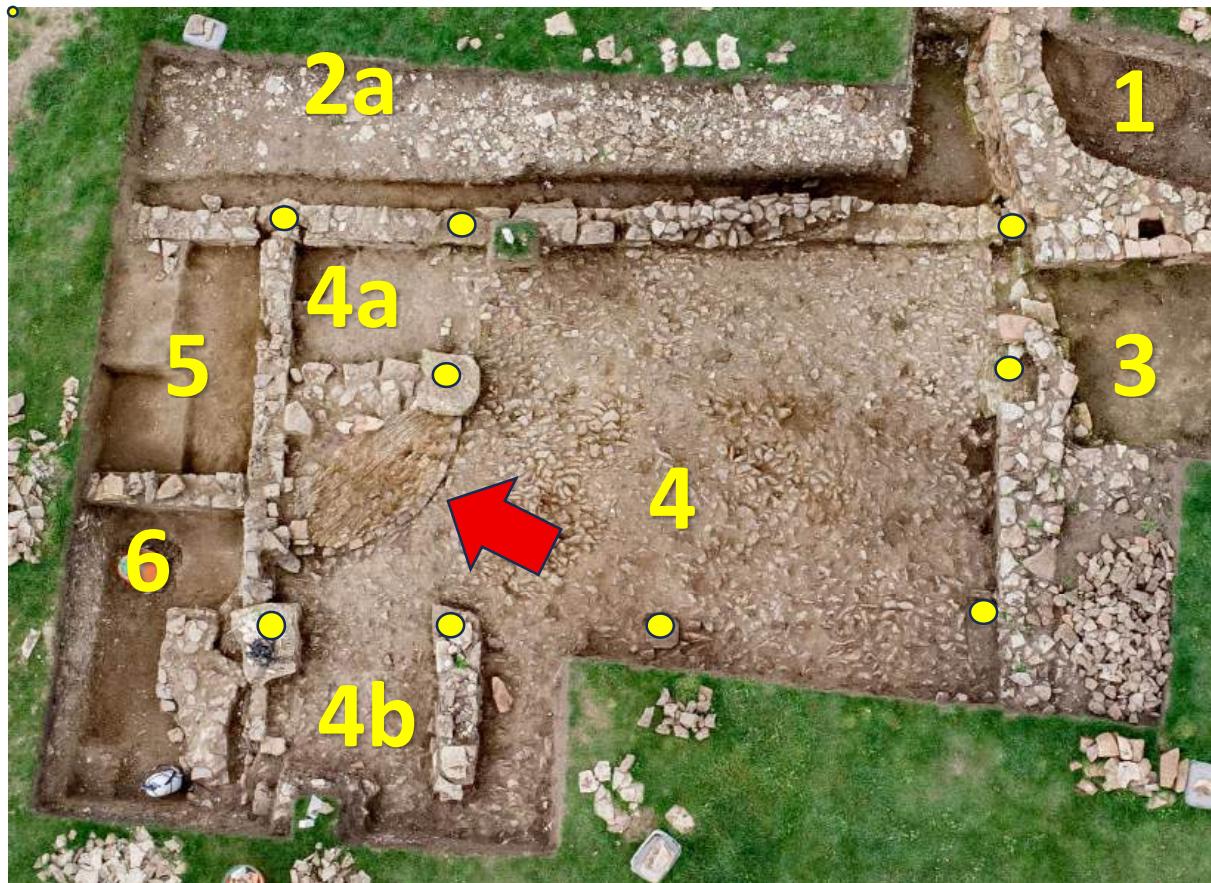
Area 4 October 2025. This area needs further investigation as it became impossible to dig & clean the stone floor properly during the dry spell as the sandy layer directly above it became as tough as concrete. A hearth is indicated by the red arrow. There are several possible padstones & padstone foundations (yellow circles) but at present it's not possible to say which belongs to which phase of the building' and which are just building material. It's thought that we have around half of area 4 excavated.

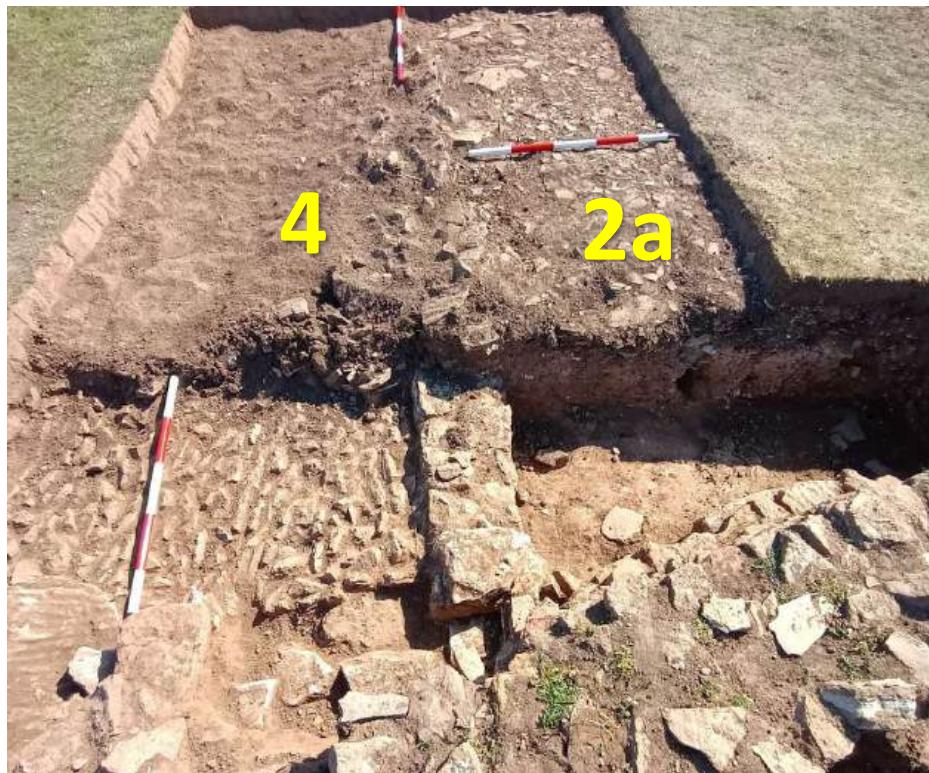
May 2025. Note how the 2a area rubble stops at the line of the north/south wall.

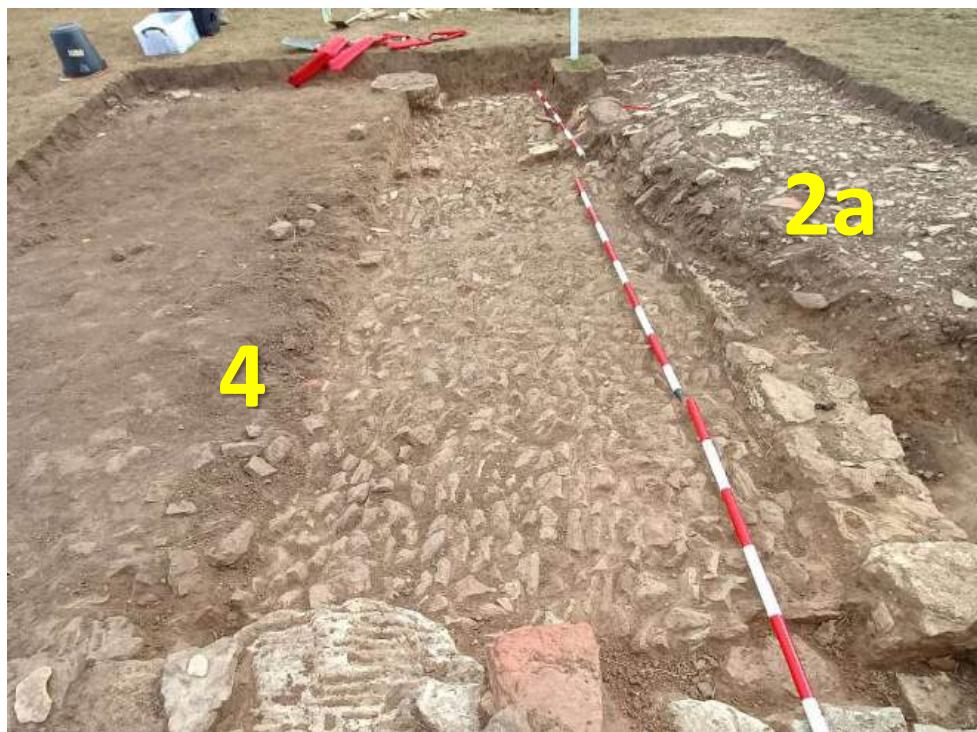
Then cascades over it. When the wall was demolished and robbed the rubble spilled over into areas 3 & 4. June 2025.

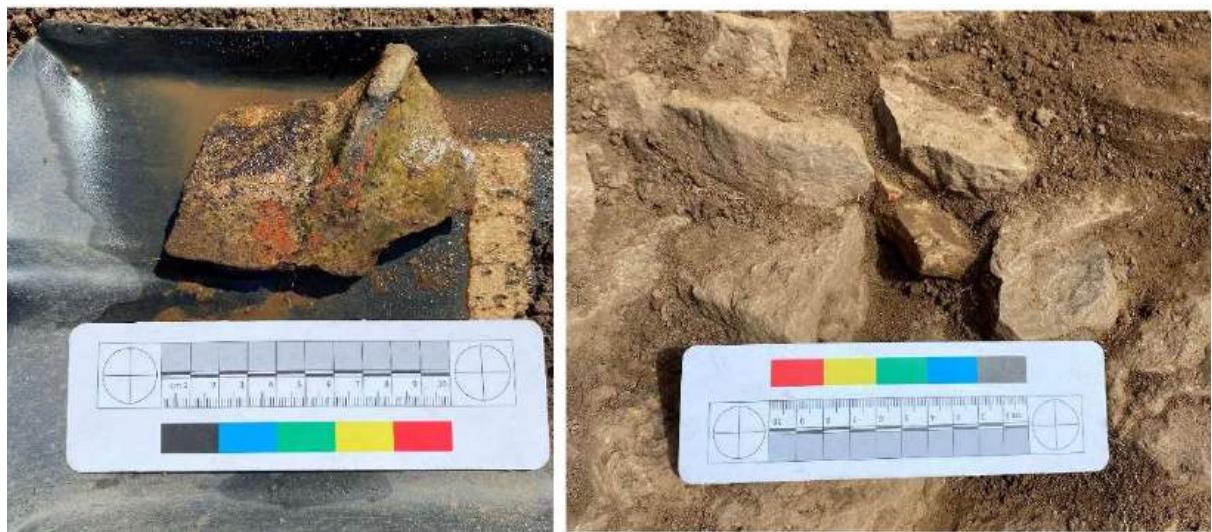
Next to the north/south wall is a stone floor which had a broken green glazed ridge tile embedded in it. The floor could be a secondary phase

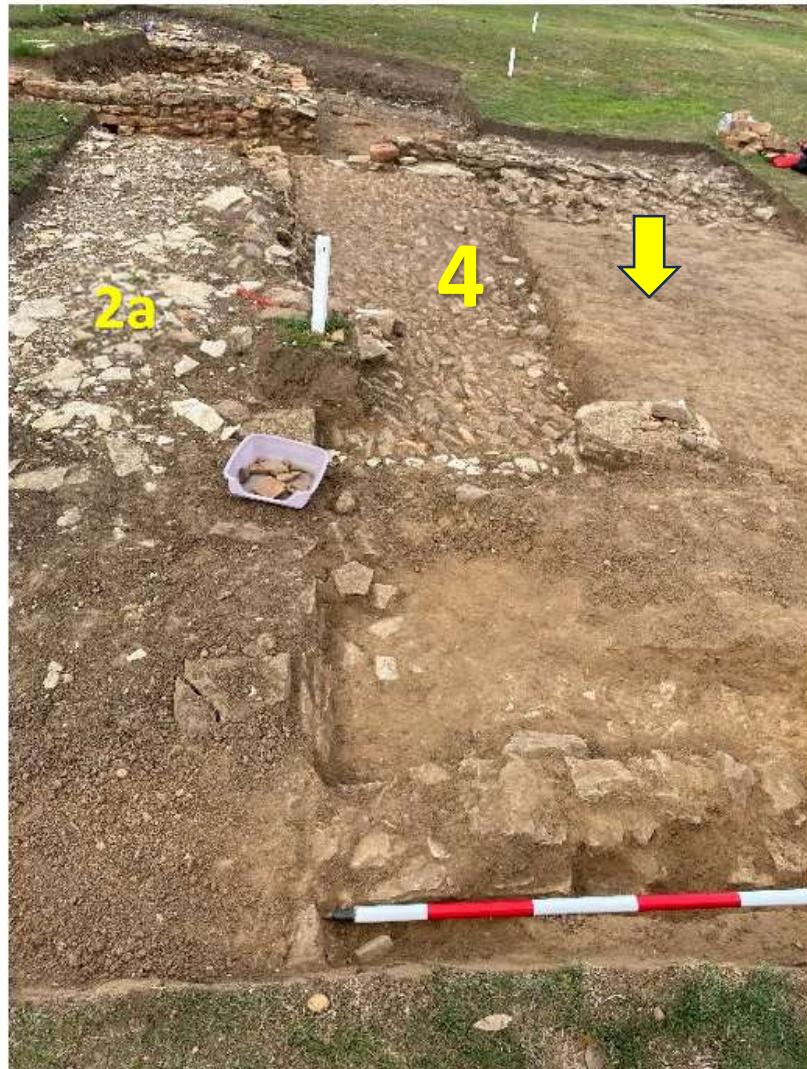
Above the stone floor was a very compacted layer of yellow sandy soil of varying thicknesses (Yellow arrow) covering the whole of area 4 and 5 including the hearth.

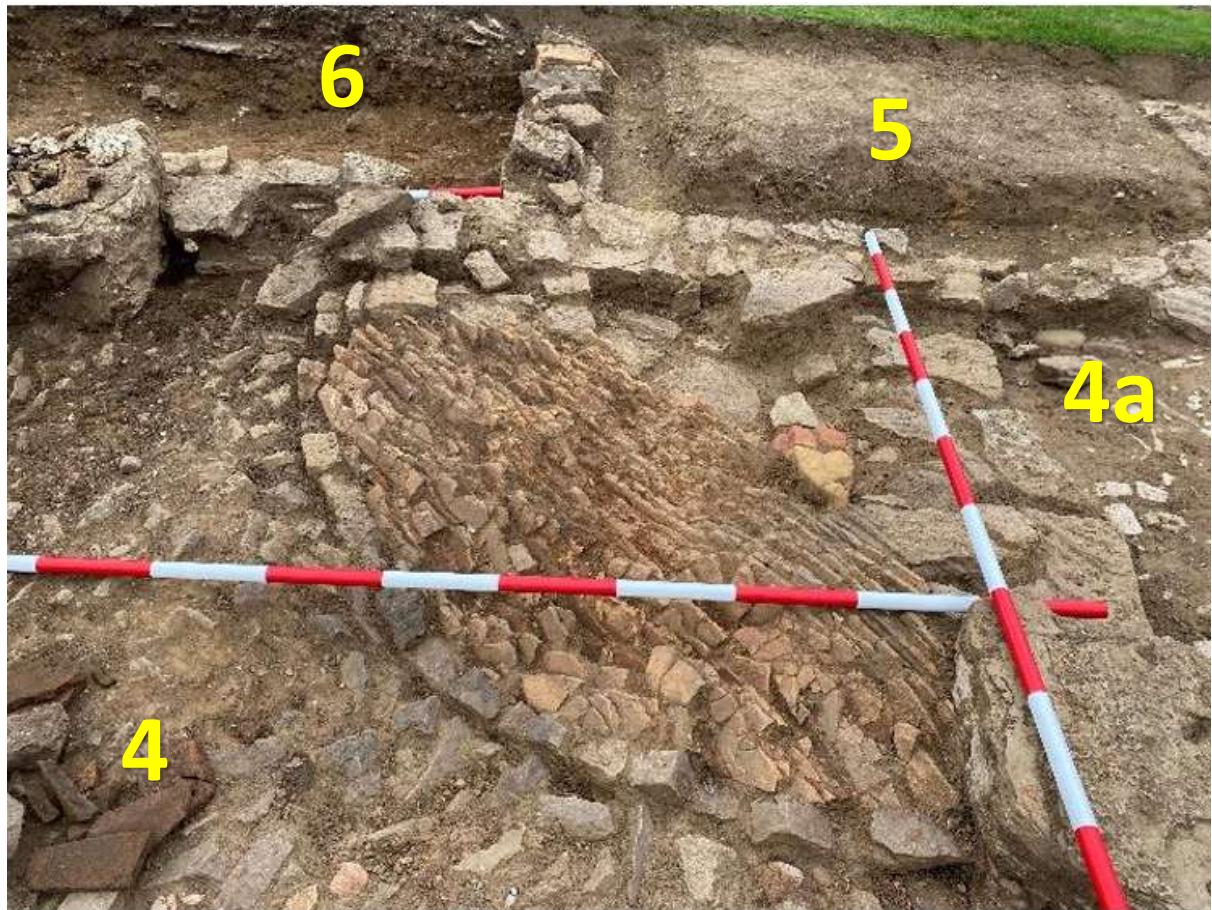
When the hearth was added, its retaining wall on the right created area 4a which may be a small room or it may form part of a corridor running south/north towards the circle. The hearth consists of broken red terracotta tiles which have been inserted end on into red clay. Its preservation is poor. The stone floor was probably added at the same time as the hearth.

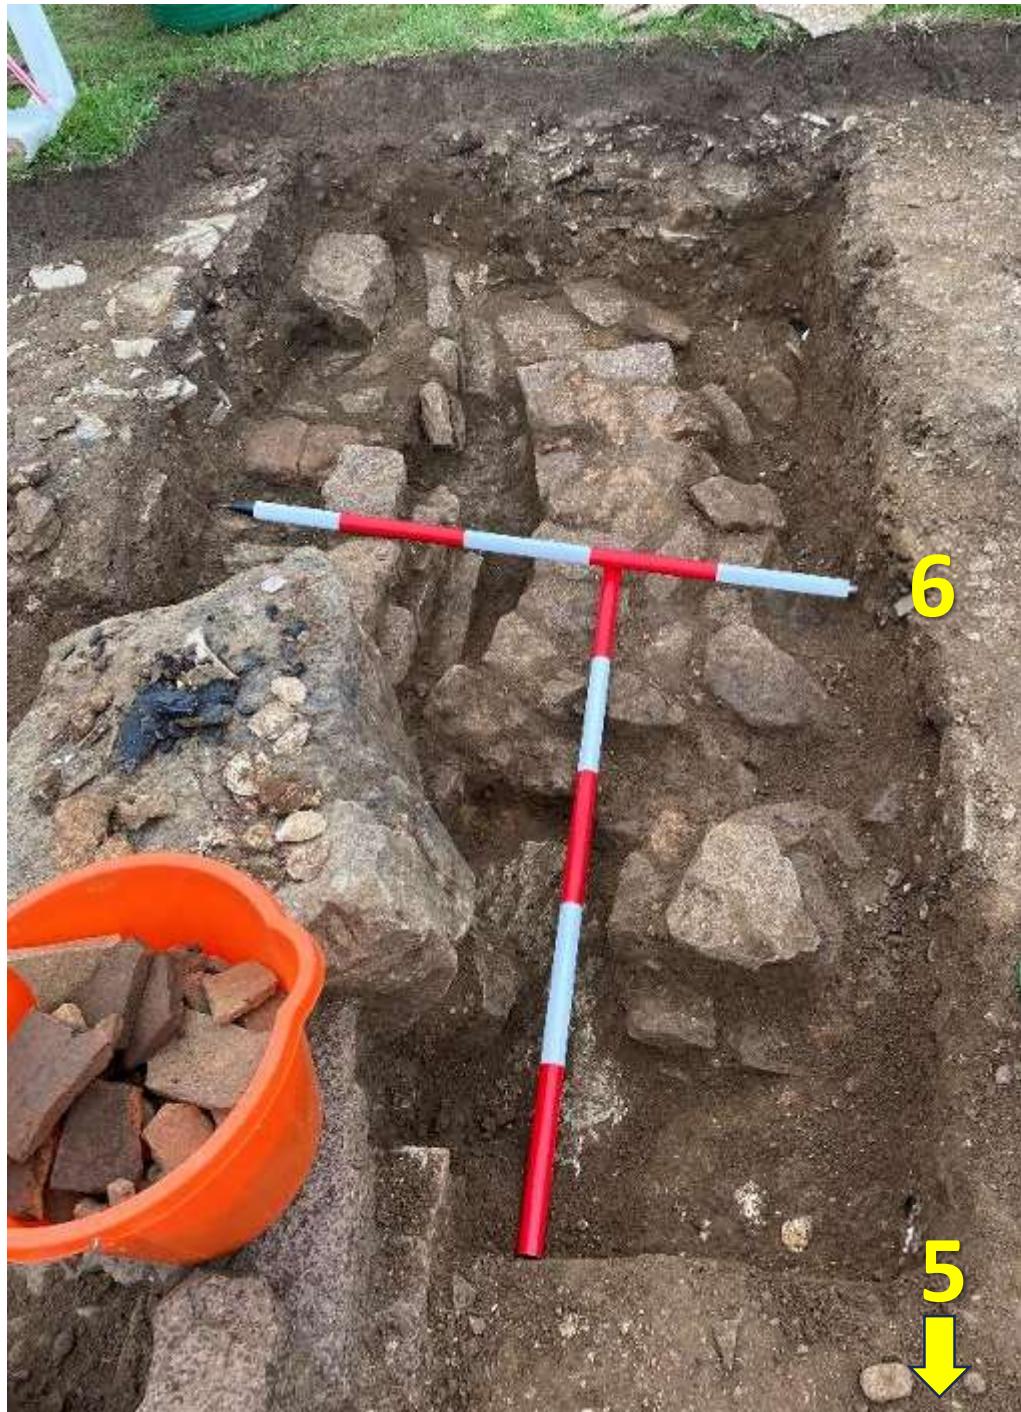
Showing mortared foundation in area 6 shortly after excavation. Note the unusual curve in the foundation.

It was unclear what the mortared foundation and the demolition related to within area 6, so a slot was cut.

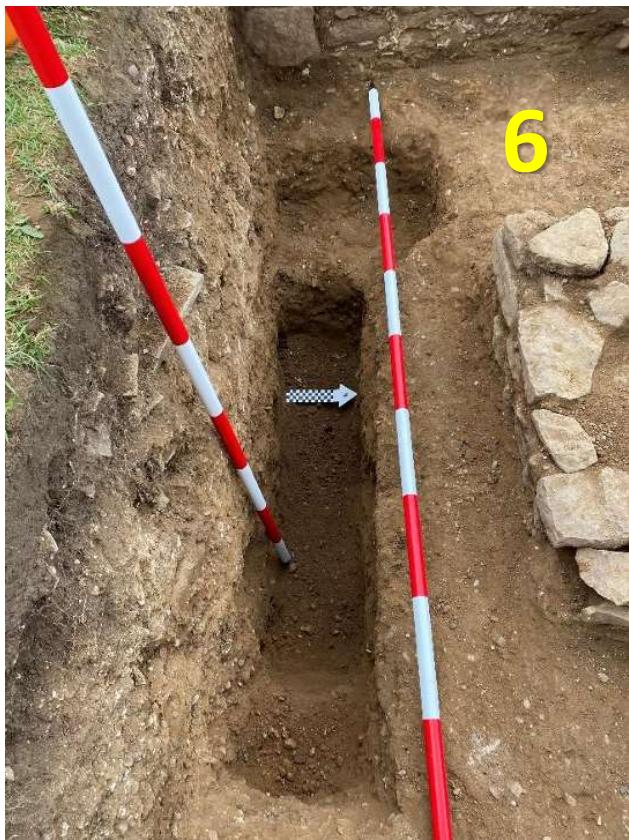
The slot revealed a demolition trench which was far deeper than was anticipated. At 1.4m below datum, the demolition debris was in danger of becoming unstable as the fill became very soft, so excavation was stopped at that point. The demolition trench was found to be approximately 60cm from the area 6 and 5 dividing wall and around 1 metre wide.

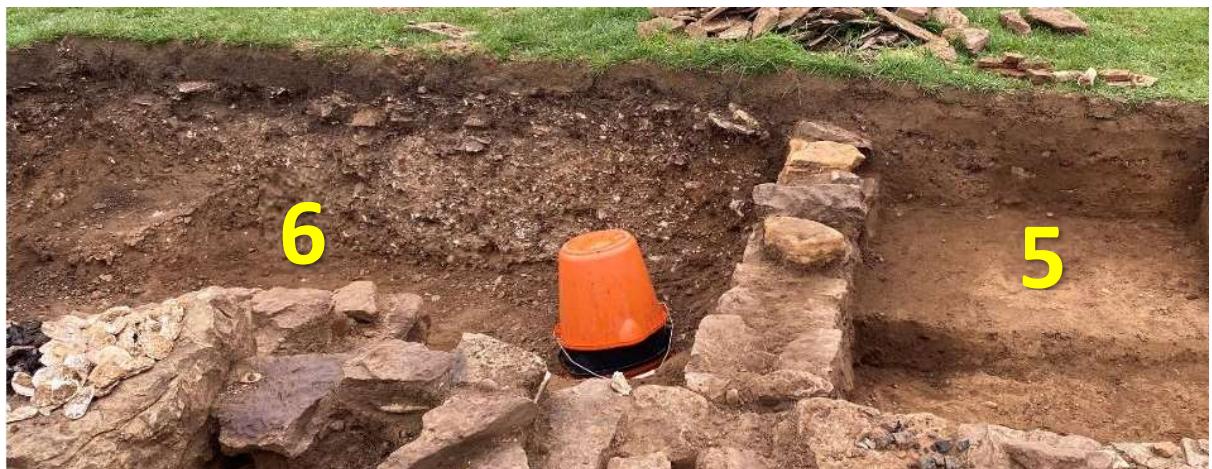
Showing the difference between the area 6 and the area 5 section fill. The demolition debris contained crushed lime mortar, fragments of stone roof tiles, red terracotta roof tiles, some were glazed, stone, charcoal, oyster shell and a few bone and pottery fragments.

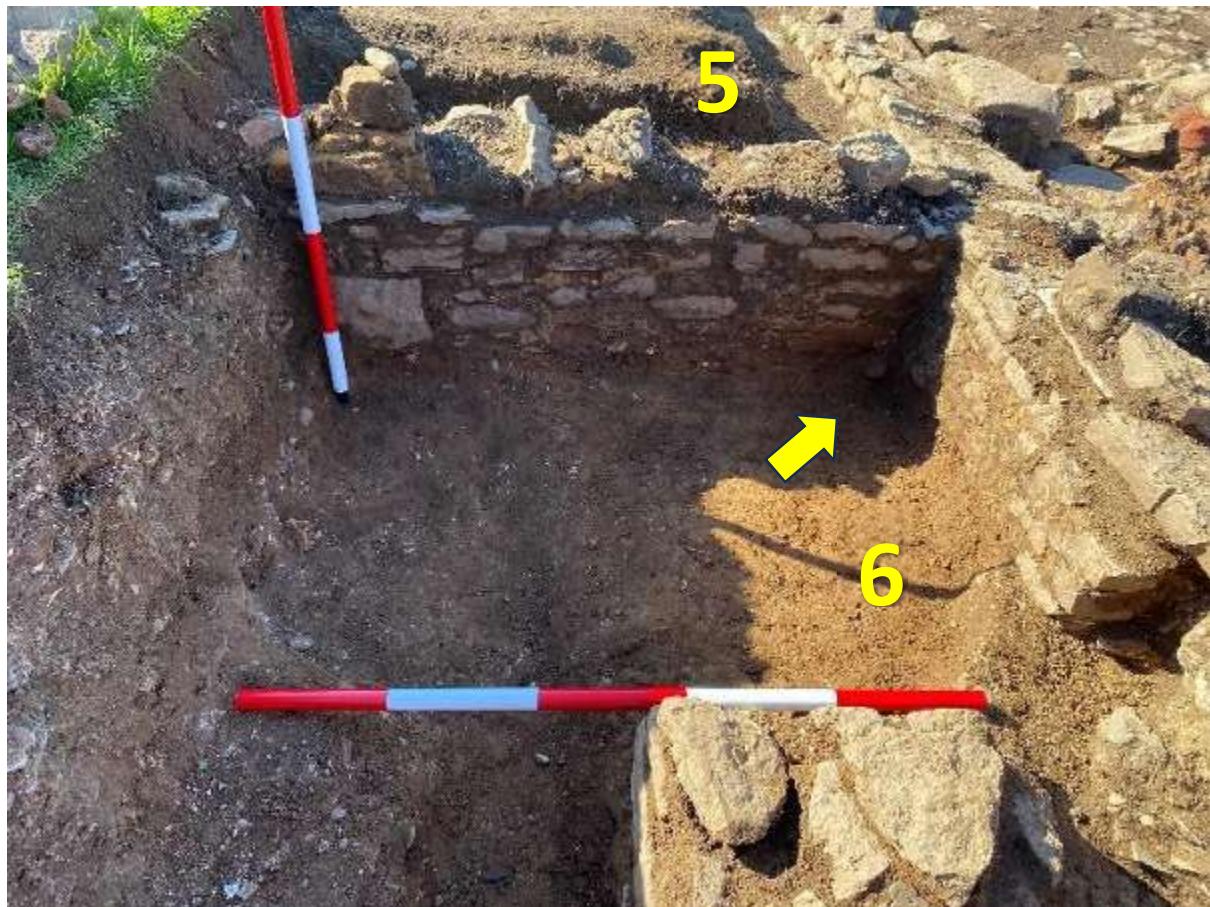
The dividing wall between area 5 and 6 was mortared and butts up to the wall to the right of the picture which runs east/west. In the right corner (arrow) were found a surprising number of oyster shells, around 86 complete ones and numerous fragments.

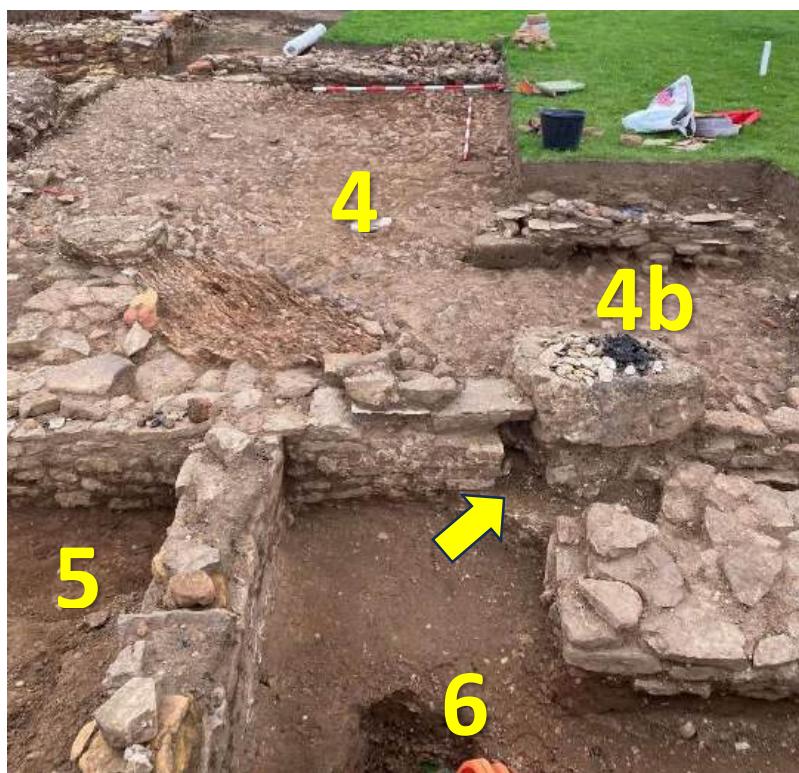
The arrow above indicates an intriguing wall break which may have been a beam slot, but more likely a drain hole?

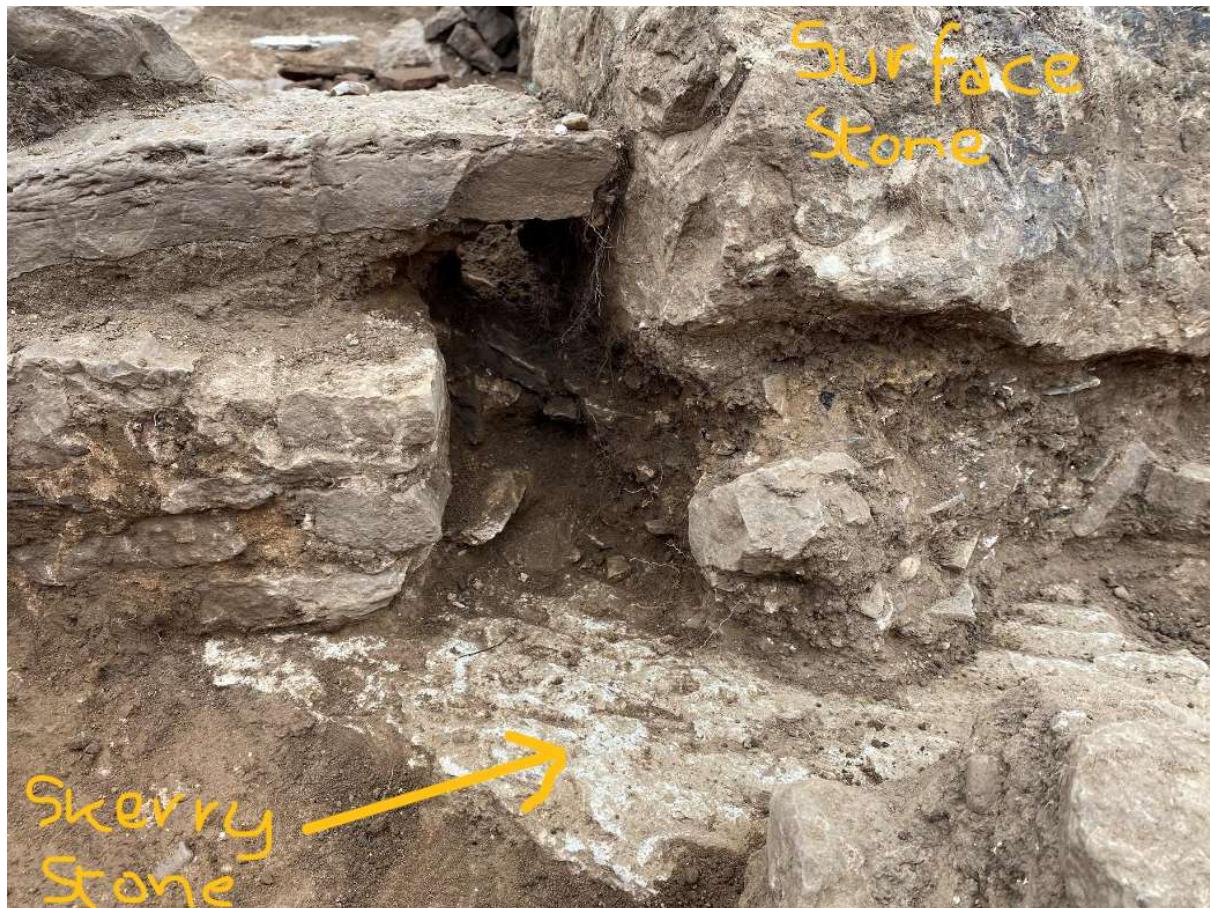
The blocked-up drain hole (above).

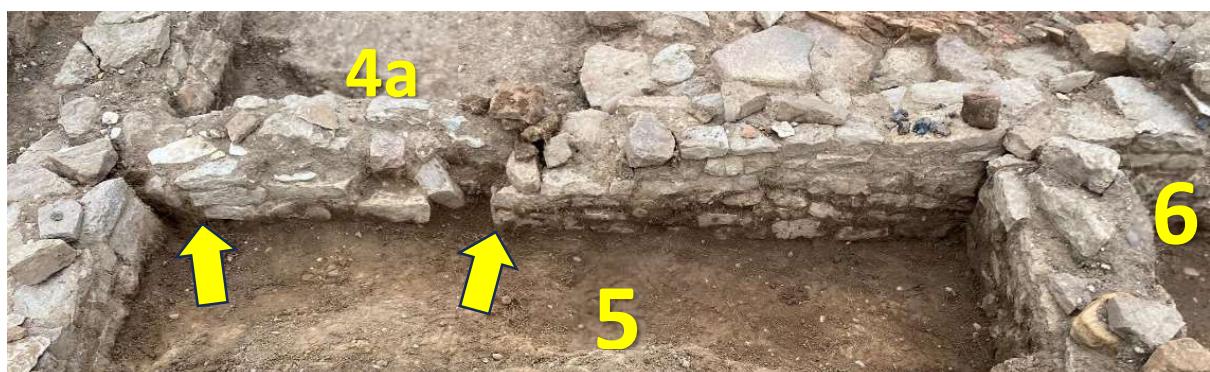
An area of very few finds with an ill-defined floor surface of hard beaten sandy soil and some gravel. However there did appear to be a blocked-up doorway between area 5 and area 4a.

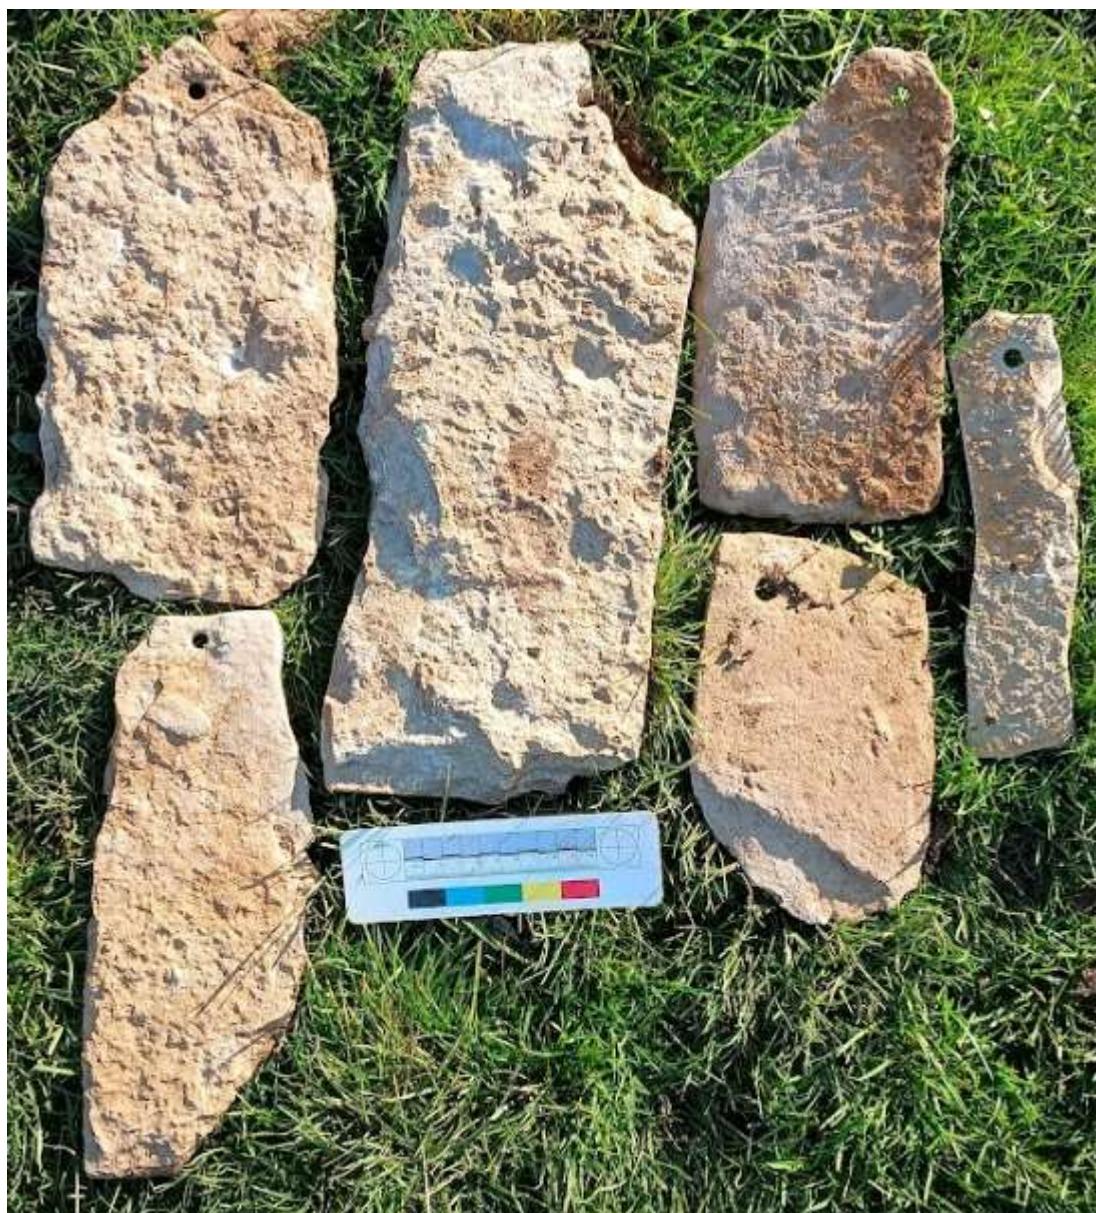
The main roofing tiles were of the same stone as found throughout the site. Some typical ones are shown below.
