# CHURCH FARM HOVERINGHAM NOTTINGHAMSHIRE HALL CLOSE INVESTIGATION

## PHASE B REPORT 2025

## HALL CLOSE INVESTIGATION

CHURCH FARM HISTORIC LANDSCAPE STUDY  
HOVERINGHAM, NOTTINGHAMSHIRE

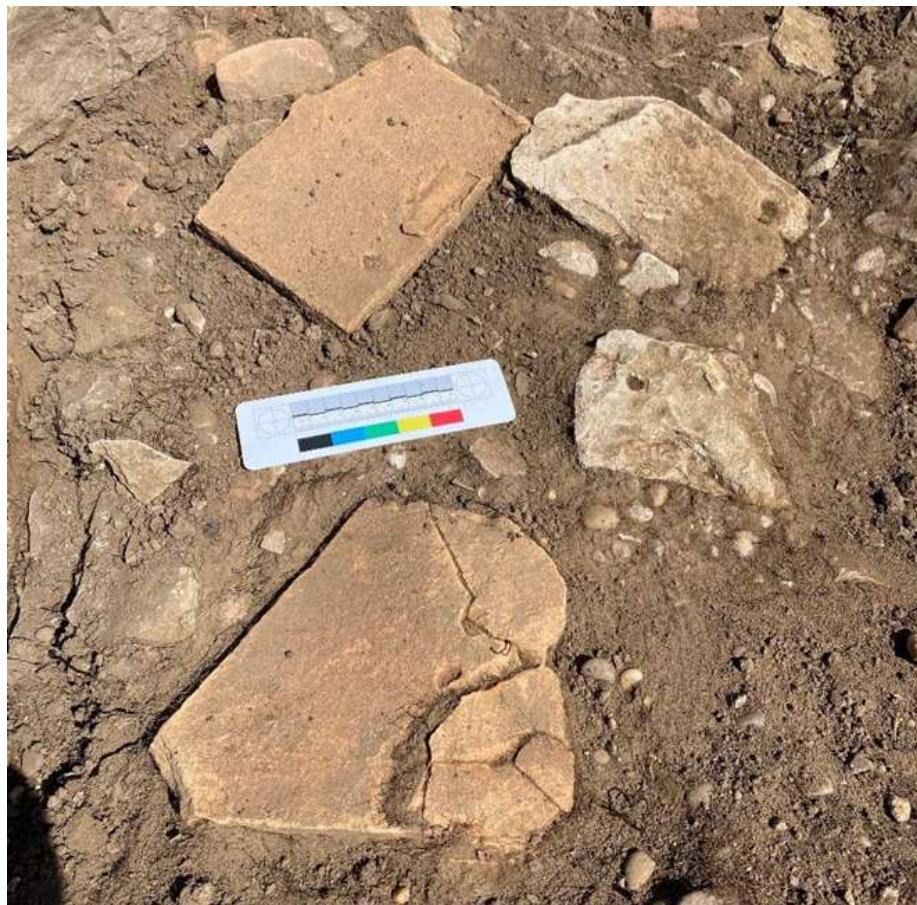
Plain red terracotta tiles in situ with a couple of stone roofing tiles (above).

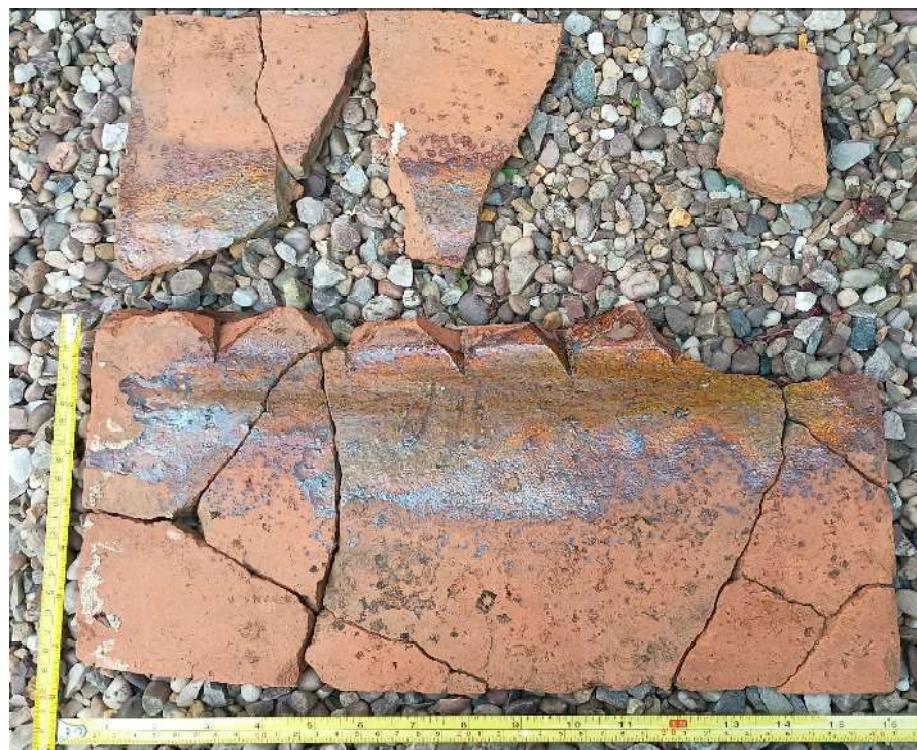
Glazed terracotta roofing tile 13<sup>th</sup> – 14<sup>th</sup> Century. Mainly found in the crushed mortar demolition rubble (above).

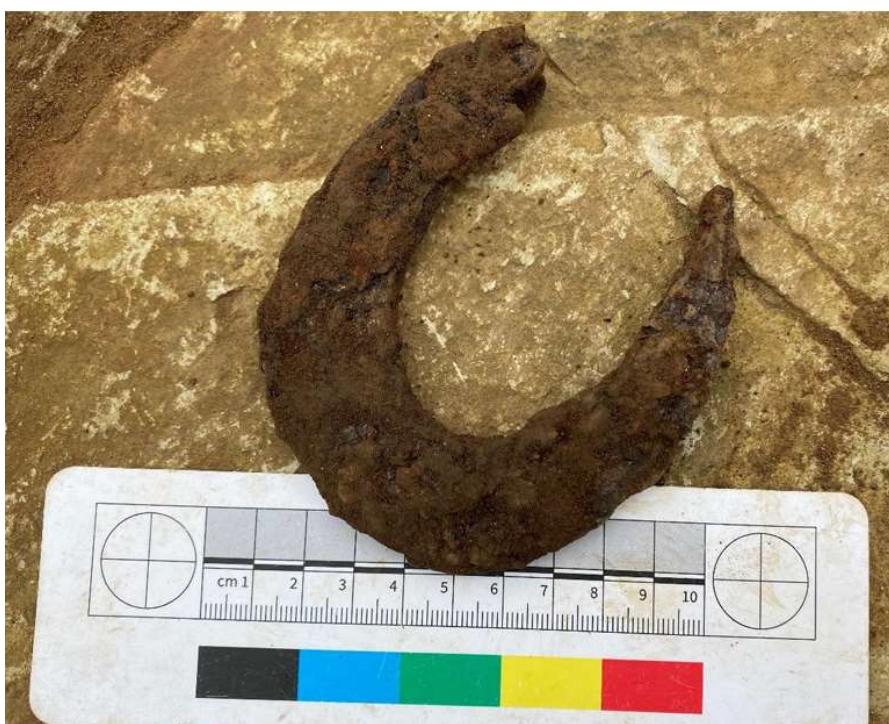
Possibly a surgical horseshoe 15th Century found in the rubble level of area 2a.

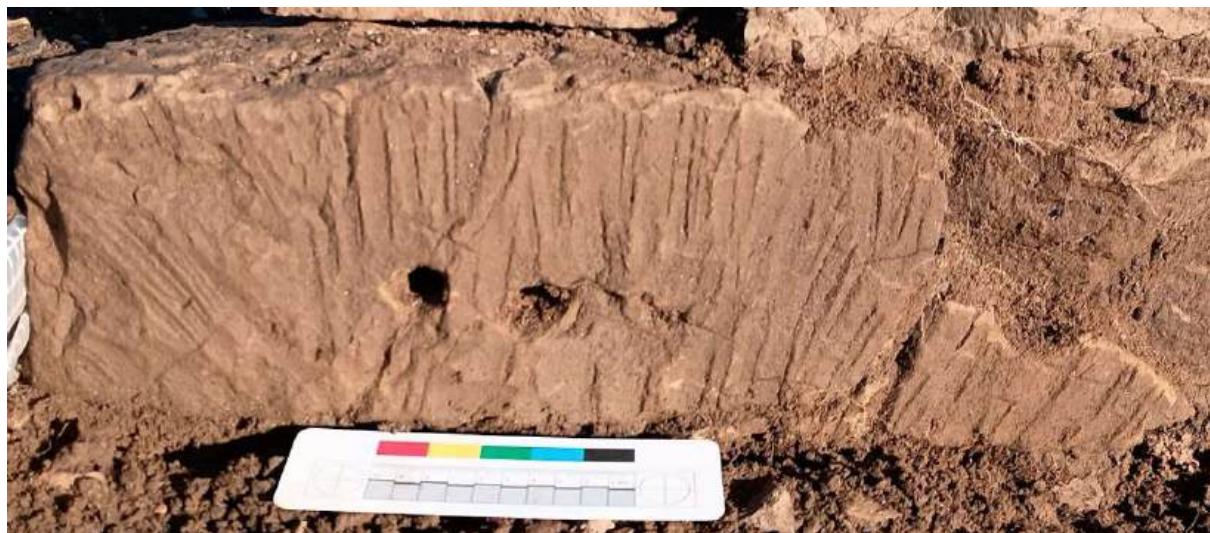
A system used by stonemasons for lifting large heavy stones (above) called a two pinned lewis. It operates by using a gripping or camming action. Two holes are drilled in the top face of the stone, typically at an angle of about 15° from vertical, sloping towards each other slightly. Then two metal pins, often linked by a short chain, are inserted into these holes. As the weight of the stone is taken up by the crane or winch, the angled pins are pulled towards the centre, forcing their lower portions firmly against the sides of the holes and gripping the stone (similar to how fingers lift a bowling ball). It is located at the end of the badly built partition wall running along side of area 4b and may have been reused as a padstone (see plan under area 4).
